SÓLHEIMAR 29 OG 35

ÍBÚÐIR FYRIR HÆLISLEITENDUR

Ástandsmat og kostnaðaráætlun

Verknúmer: 23297

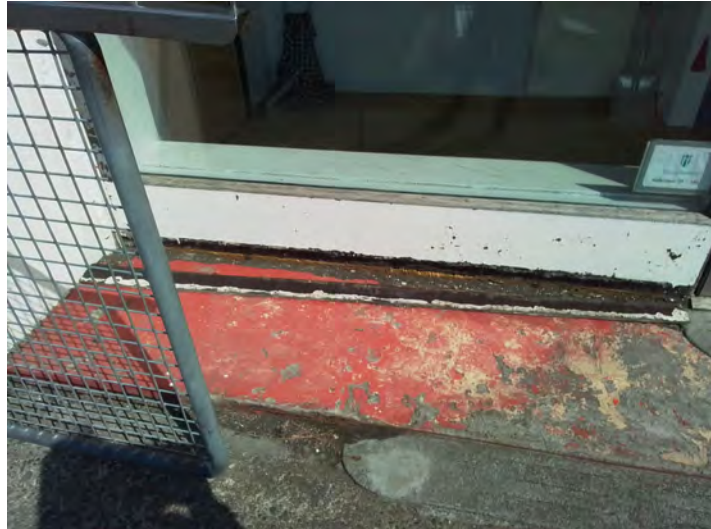
#140	Type: Defect	Project folder: Sólheimar 35	
Deadline from: 06-06-23 - To: 06-06-23		Category / List: 09 EÁ - Frágangur uttanhúss / Gluggar og útihurðir	
Description		Receiver	Responsible
<p>The latest comment</p>  		RECEIVED	CREATED
		07-06-23, 14:24:43 VSÓ Ráðgjöf Þórunn Arnardóttir	07-06-23, 14:23:21 VSÓ Ráðgjöf Þórunn Arnardóttir

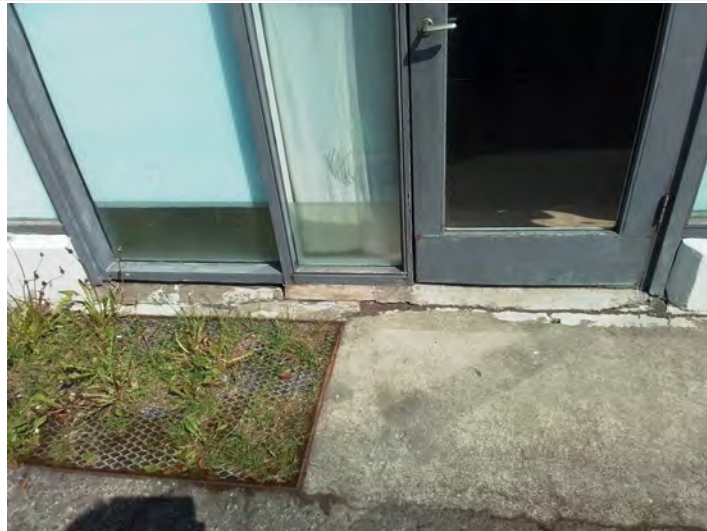
#139	Type: Defect	Project folder: Sólheimar 35
Deadline from: 06-06-23 - To: 06-06-23		Category / List: 09 EÁ - Frágangur uttanhúss / Gluggar og útihurðir
Description		Receiver
		RECEIVED 07-06-23, 14:24:43 VSÓ Ráðgjöf Þórunn Arnardóttir
		Responsible
		CREATED 07-06-23, 14:22:46 VSÓ Ráðgjöf Þórunn Arnardóttir
The latest comment 0

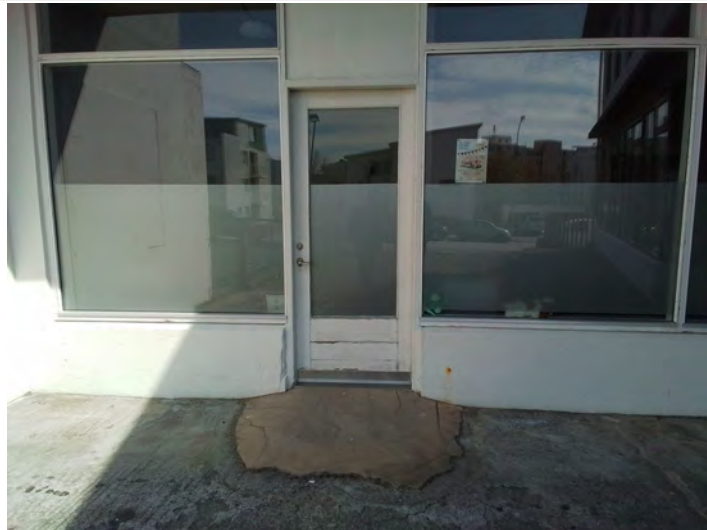
#136	Type: Defect	Project folder: Sólheimar 35	
Deadline from: 06-06-23 - To: 06-06-23		Category / List: 09 EÁ - Frágangur uttanhúss / Gluggar og útihurðir	
Description		Receiver	Responsible
<p>The latest comment</p>  		RECEIVED	CREATED
		07-06-23, 14:24:43 VSÓ Ráðgjöf Þórunn Arnardóttir	07-06-23, 14:19:48 VSÓ Ráðgjöf Þórunn Arnardóttir

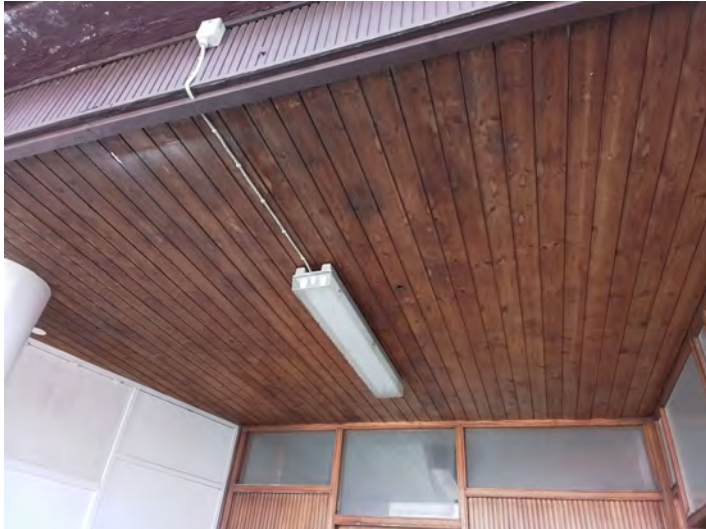
#135	Type: Defect	Project folder: Sólheimar 35
Deadline from: 06-06-23 - To: 06-06-23		Category / List: 09 EÁ - Frágangur uttanhúss / Gluggar og útihurðir
Description		Receiver
<p>The latest comment</p>  		<p>RECEIVED 07-06-23, 14:24:43</p> <p>VSÓ Ráðgjöf Þórunn Arnardóttir</p>
		Responsible
		<p>CREATED 07-06-23, 14:19:18</p> <p>VSÓ Ráðgjöf Þórunn Arnardóttir</p>

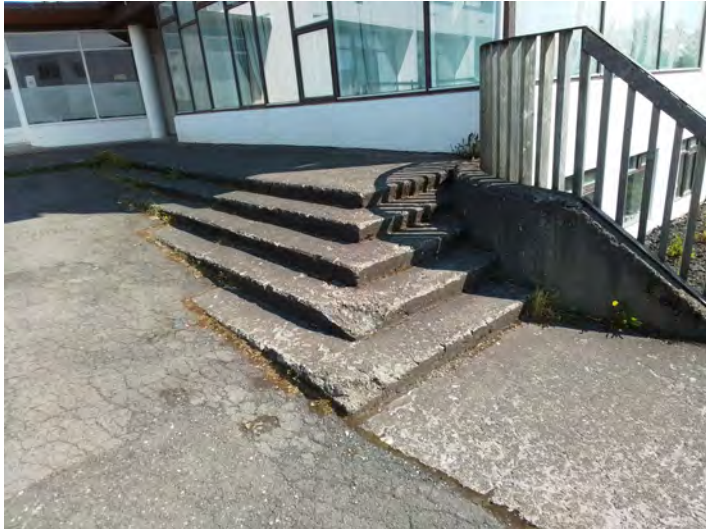
#133	Type: Defect	Project folder: Sólheimar 35
Deadline from: 06-06-23 - To: 06-06-23		Category / List: 09 EÁ - Frágangur uttanhúss / Gluggar og útihurðir
Description		Receiver
malbik stétt og handrið illa farið		RECEIVED 07-06-23, 14:24:43
		VSÓ Ráðgjöf Þórunn Arnardóttir
The latest comment		RESPONSIBLE
		CREATED 07-06-23, 14:17:23
		VSÓ Ráðgjöf Þórunn Arnardóttir

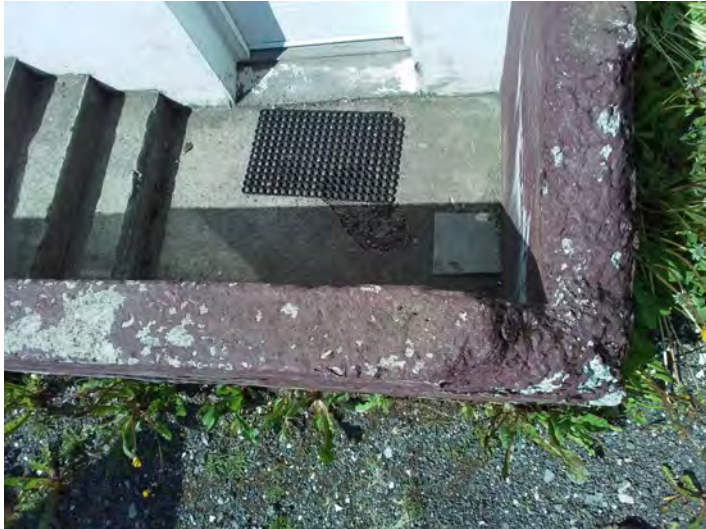
#130	Type: Defect	Project folder: Sólheimar 35	
Deadline from: 06-06-23 - To: 06-06-23		Category / List: 09 EÁ - Frágangur uttanhúss / Gluggar og útihúðir	
Description		Receiver	Responsible
brotið		RECEIVED 07-06-23, 14:24:42 VSÓ Ráðgjöf Þórunn Arnardóttir	CREATED 07-06-23, 14:15:12 VSÓ Ráðgjöf Þórunn Arnardóttir
The latest comment 0

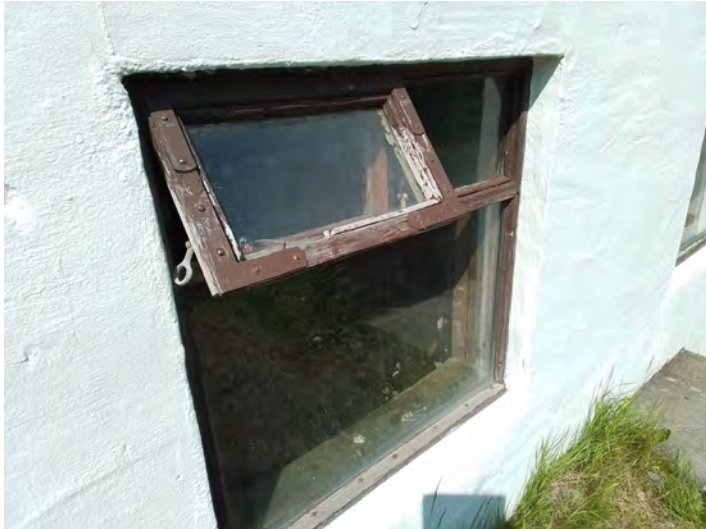
#129	Type: Defect	Project folder: Sólheimar 35	
Deadline from: 06-06-23 - To: 06-06-23		Category / List: 09 EÁ - Frágangur uttanhúss / Gluggar og útihurðir	
Description		Receiver	Responsible
ónýtt		RECEIVED VSÓ Ráðgjöf Þórunn Arnardóttir	CREATED VSÓ Ráðgjöf Þórunn Arnardóttir
<p>The latest comment</p>

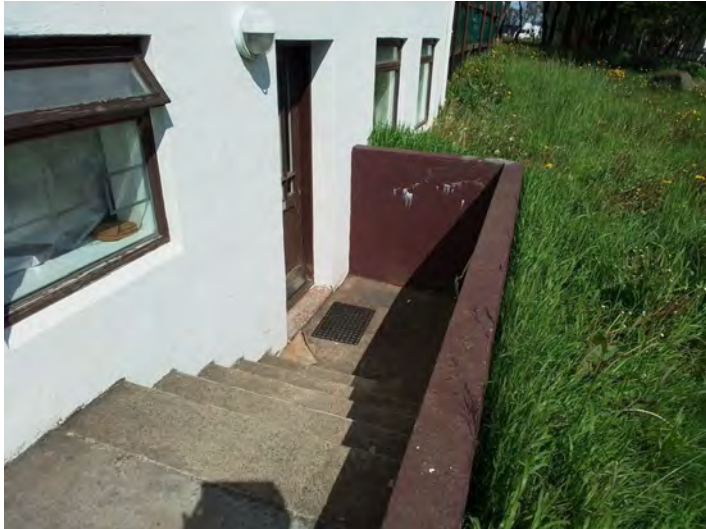
#128	Type: Defect	Project folder: Sólheimar 35
Deadline from: 06-06-23 - To: 06-06-23		Category / List: 09 EÁ - Frágangur uttanhúss / Gluggar og útihurðir
Description		Receiver
		RECEIVED 07-06-23, 14:24:42 VSÓ Ráðgjöf Þórunn Arnardóttir
		RESPONSIBLE 07-06-23, 14:14:19 VSÓ Ráðgjöf Þórunn Arnardóttir
The latest comment 0

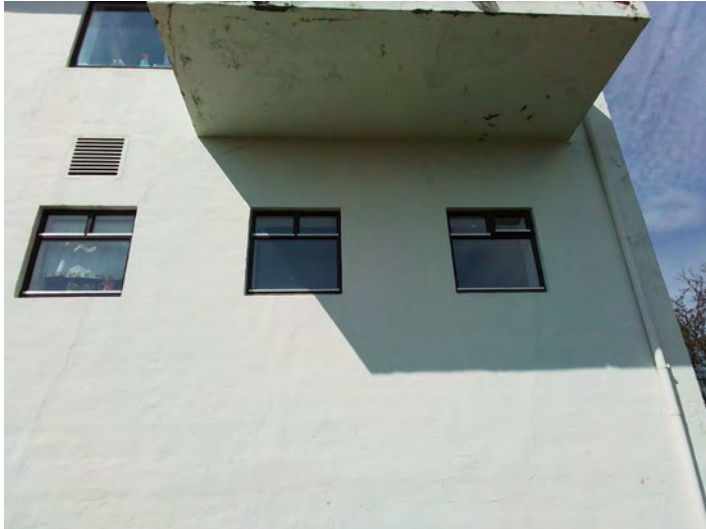
#126	Type: Defect	Project folder: Sólheimar 35	
Deadline from: 06-06-23 - To: 06-06-23		Category / List: 09 EÁ - Frágangur uttanhúss / Gluggar og útihurðir	
Description		Receiver	Responsible
ál listar á gluggum		RECEIVED VSÓ Ráðgjöf Þórunn Arnardóttir	CREATED VSÓ Ráðgjöf Þórunn Arnardóttir
The latest comment		0

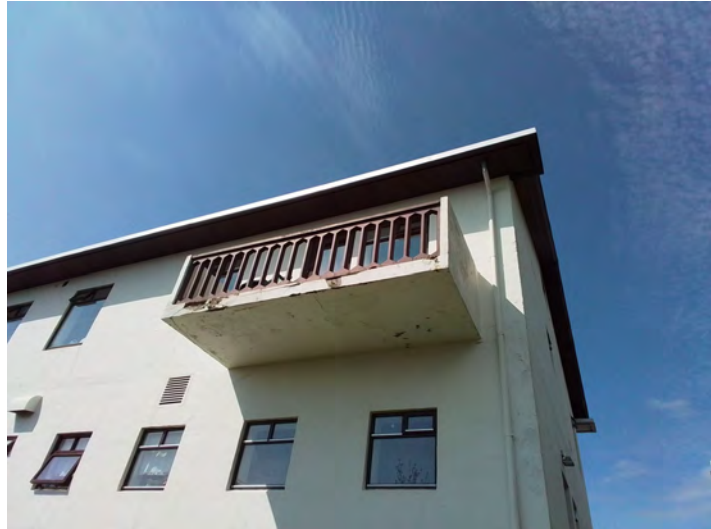
#125	Type: Defect	Project folder: Sólheimar 35	
Deadline from: 06-06-23 - To: 06-06-23		Category / List: 09 EÁ - Frágangur uttanhúss / Gluggar og útihurðir	
Description		Receiver	Responsible
svalir illa farnar		RECEIVED 07-06-23, 14:24:42 VSÓ Ráðgjöf Þórunn Arnardóttir	CREATED 07-06-23, 14:12:51 VSÓ Ráðgjöf Þórunn Arnardóttir
The latest comment 0

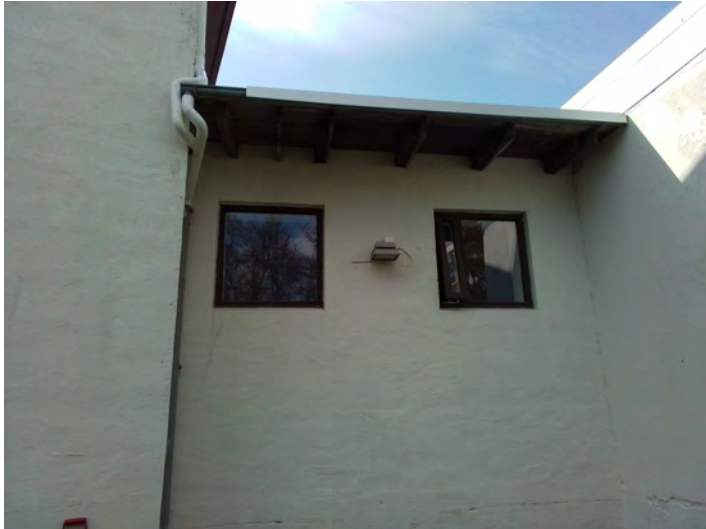
#123	Type: Defect	Project folder: Sólheimar 35	
Deadline from: 06-06-23 - To: 06-06-23		Category / List: 09 EÁ - Frágangur uttanhúss / Gluggar og útihurðir	
Description		Receiver	Responsible
viðargluggar kominn tími á endurnýjun		RECEIVED VSÓ Ráðgjöf Þórunn Arnardóttir	CREATED VSÓ Ráðgjöf Þórunn Arnardóttir
The latest comment

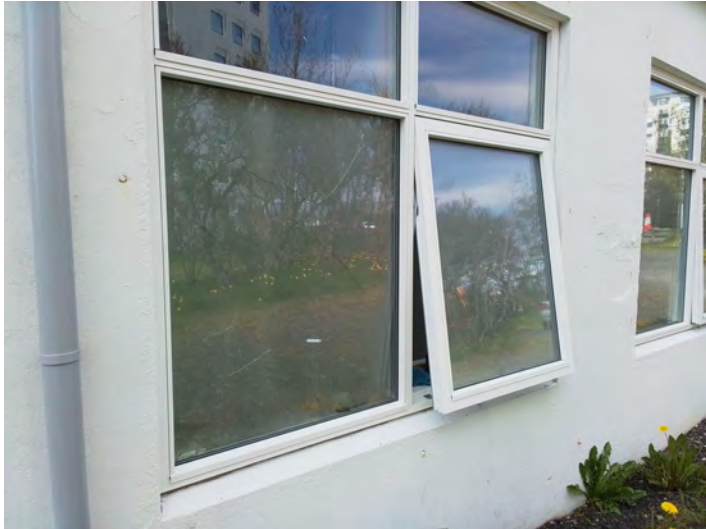
#120	Type: Defect	Project folder: Sólheimar 35	
Deadline from: 06-06-23 - To: 06-06-23		Category / List: 09 EÁ - Frágangur uttanhúss / Gluggar og útihurðir	
Description		Receiver	Responsible
Rúða brotin		RECEIVED VSÓ Ráðgjöf Þórunn Arnardóttir	CREATED VSÓ Ráðgjöf Þórunn Arnardóttir
The latest comment		0

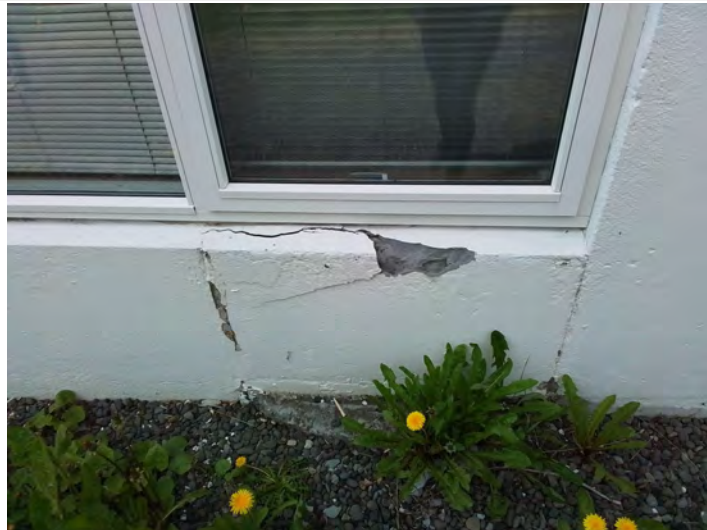
#119	Type: Defect	Project folder: Sólheimar 35	
Deadline from: 06-06-23 - To: 06-06-23		Category / List: 09 EÁ - Frágangur uttanhúss / Gluggar og útihurðir	
Description		Receiver	Responsible
Steypuskemmd		RECEIVED VSÓ Ráðgjöf Þórunn Arnardóttir	CREATED VSÓ Ráðgjöf Þórunn Arnardóttir
The latest comment

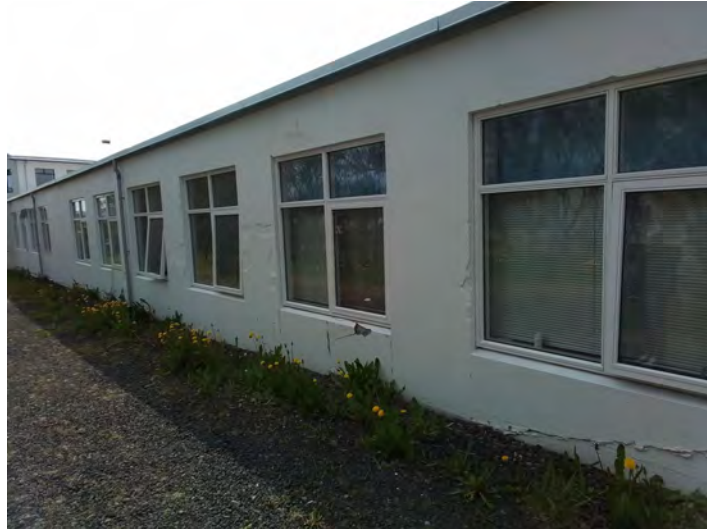
#118	Type: Defect	Project folder: Sólheimar 35	
Deadline from: 06-06-23 - To: 06-06-23		Category / List: 09 EÁ - Frágangur uttanhúss / Gluggar og útihurðir	
Description		Receiver	Responsible
áltrégluggar		RECEIVED VSÓ Ráðgjöf Þórunn Arnardóttir	CREATED VSÓ Ráðgjöf Þórunn Arnardóttir
07-06-23, 14:24:42		07-06-23, 14:06:23	
The latest comment

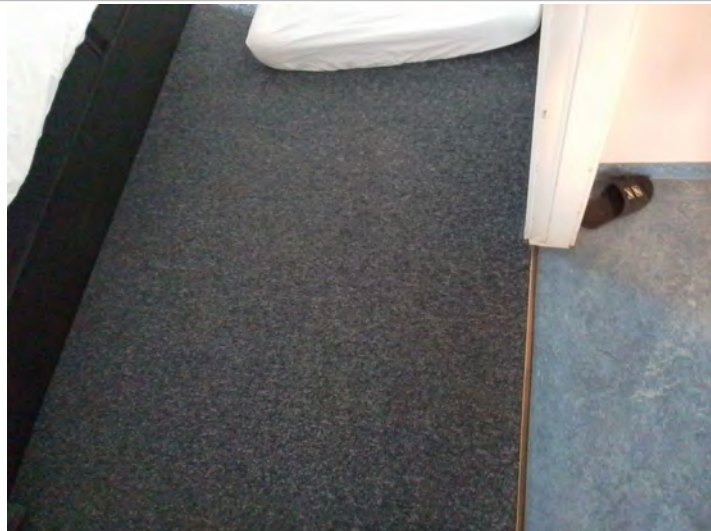
#106	Type: Defect	Project folder: Sólheimar 35	
Deadline from: 04-06-23 - To: 04-06-23		Category / List: 09 EÁ - Frágangur innanhúss / Almennt	
Description		Receiver	Responsible
reykskynjari		RECEIVED 05-06-23, 15:24:02 VSÓ Ráðgjöf Þórunn Arnardóttir	CREATED 05-06-23, 15:09:37 VSÓ Ráðgjöf Þórunn Arnardóttir
The latest comment 0
