SÓLHEIMAR 29 OG 35

ÍBÚÐIR FYRIR HÆLISLEITENDUR

Ástandsmat og kostnaðaráætlun

Verknúmer: 23297

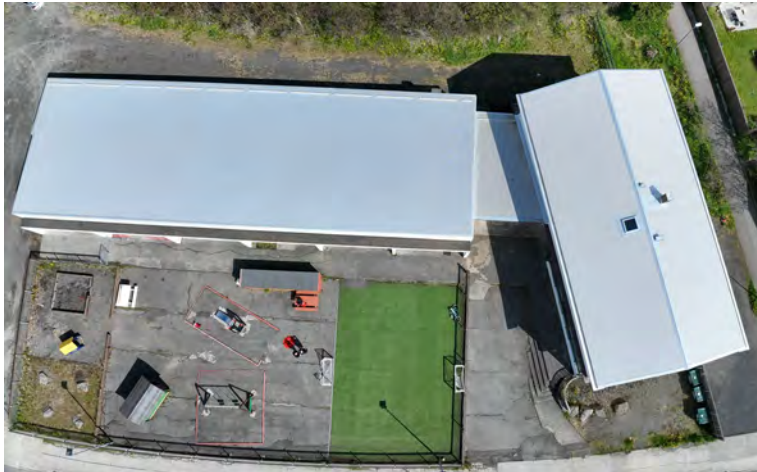
Mynd 1: Hér má sjá hluta lóðar við Sólheima 29 og 35.

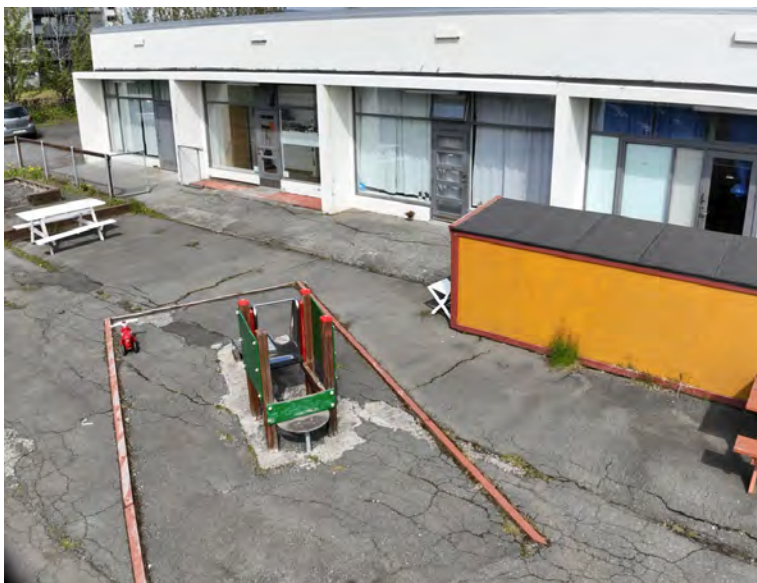
Mynd 2: Leikvöllur.

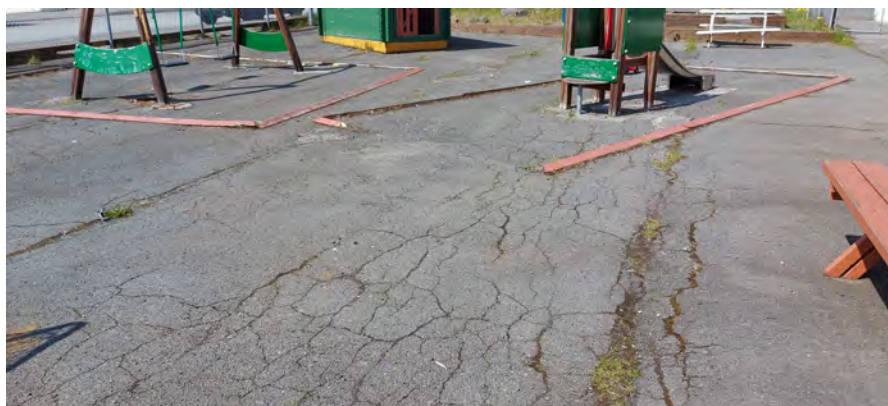
Mynd 3: Malbik sprungið.

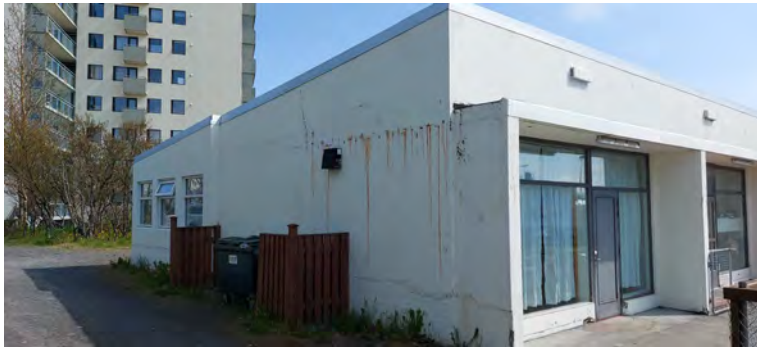
Mynd 4: Norðvestur gafl. Útveggir illa farnir.

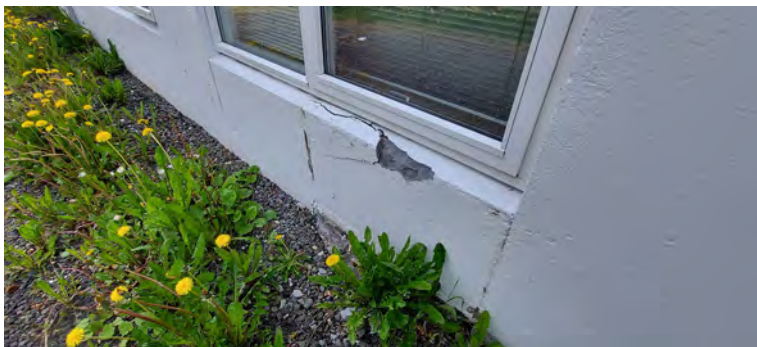
Mynd 5: Bakhlíð hússins. Útveggir illa farnir.

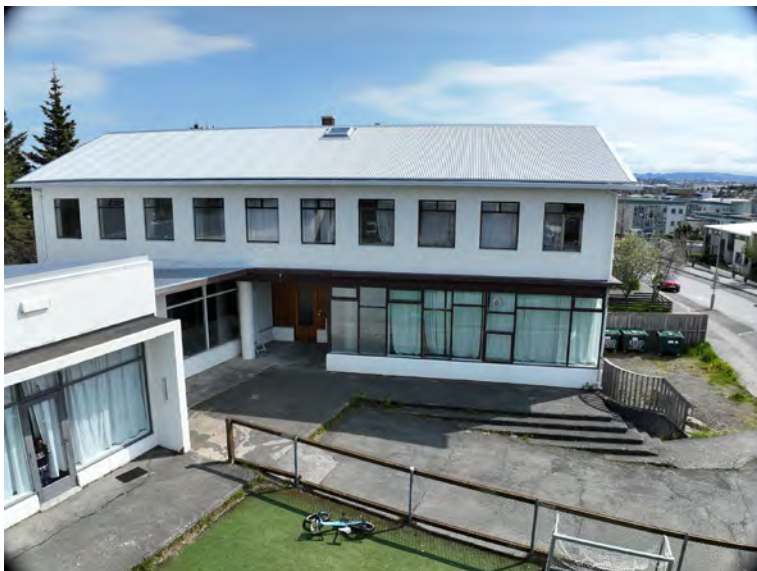
Mynd 6: Framhlíð hússins.

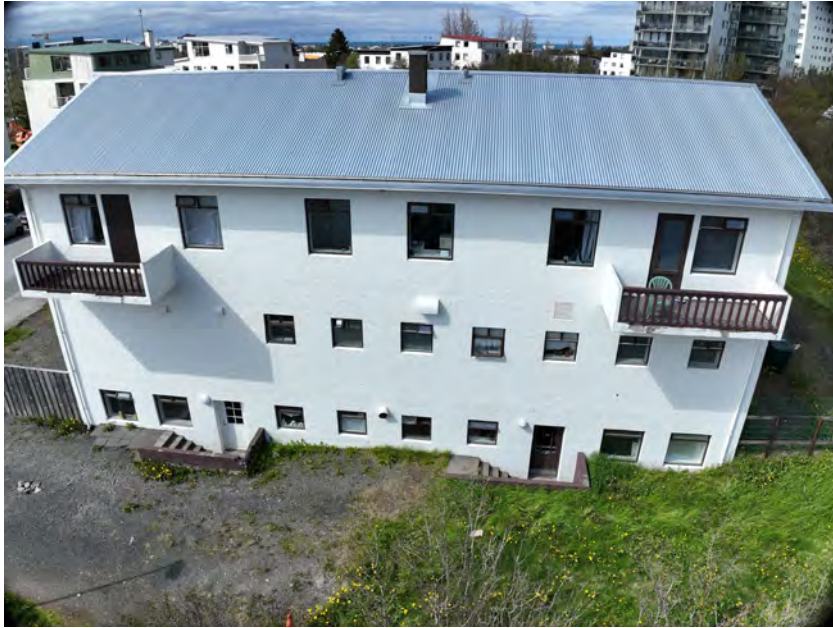
Mynd 7: Baklið hússins.

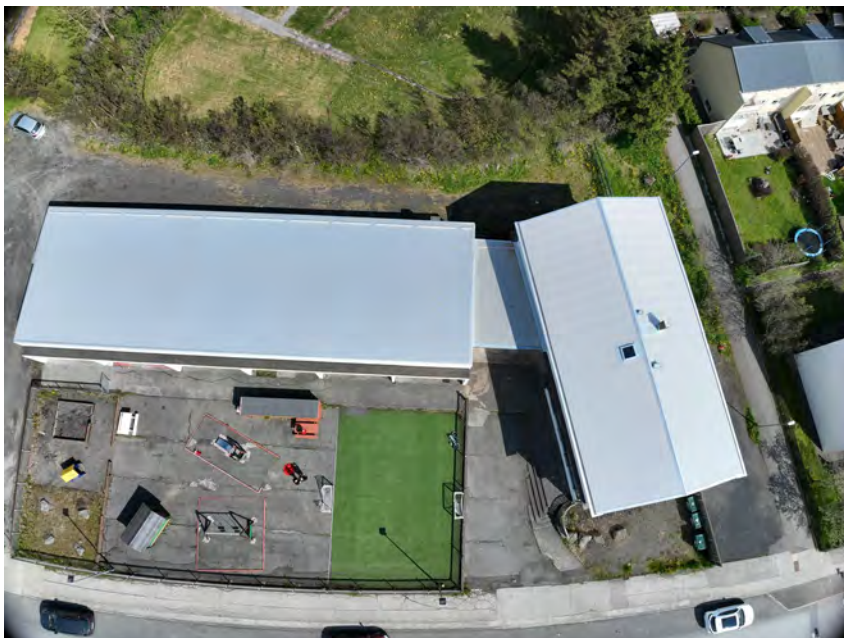
Mynd 8: Yfirlitsmynd af húsinu. Þakið nýlega uppgert.

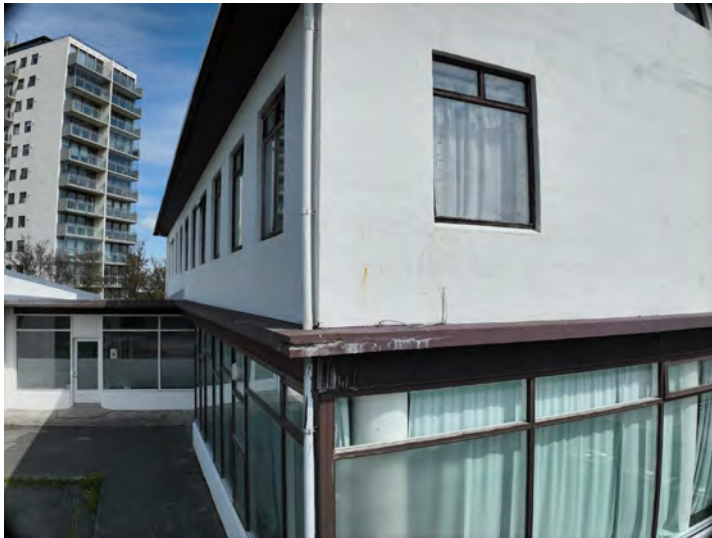
Mynd 9: Skyggni fyrir ofan 1. hæð.

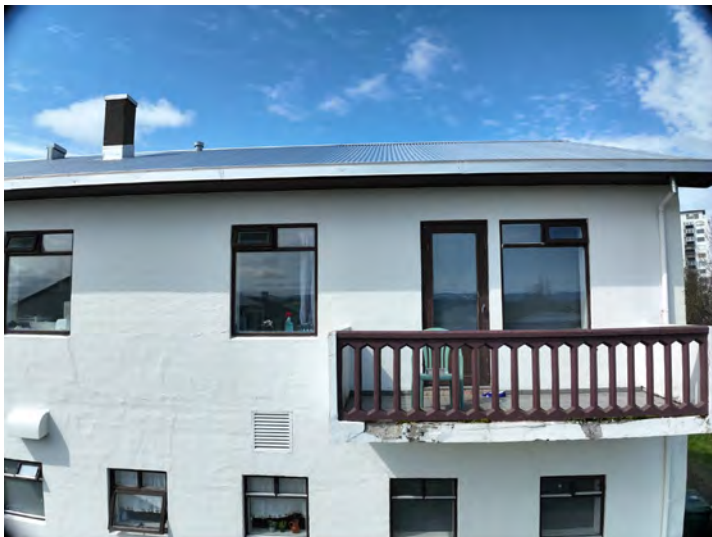
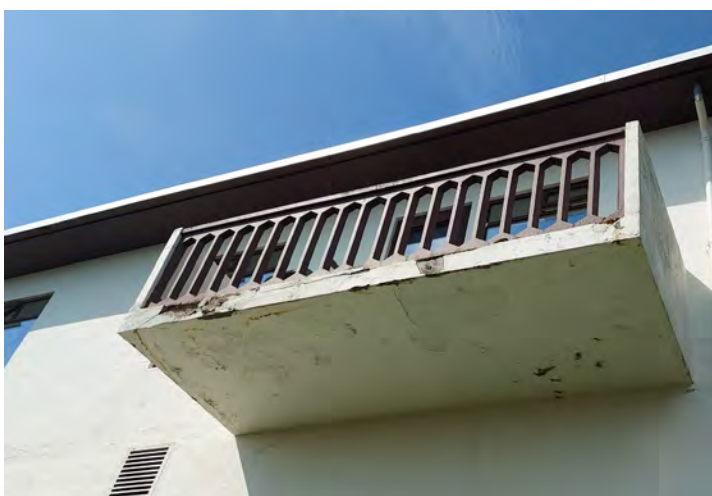
Mynd 10: Hér sést hvað svalimar eru illa farnar.

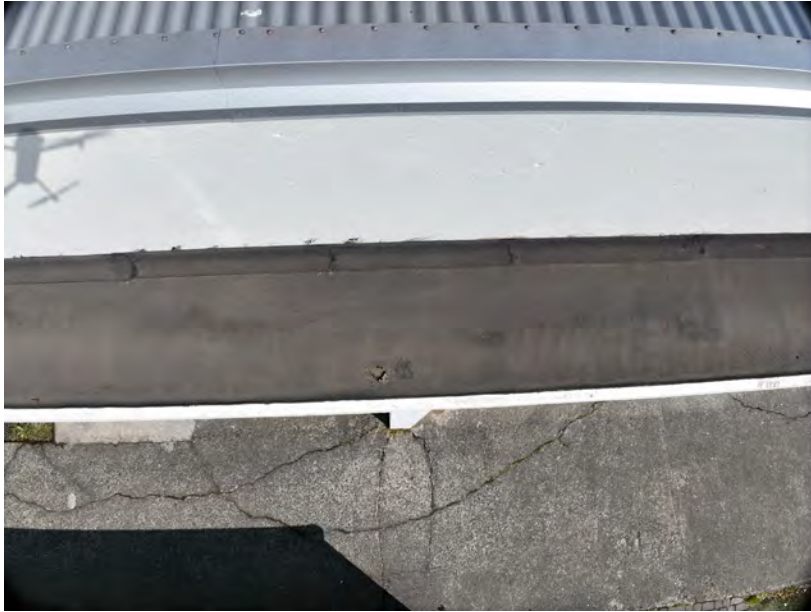
Mynd 11: Þakpappi götóttur og stétt illa farin.

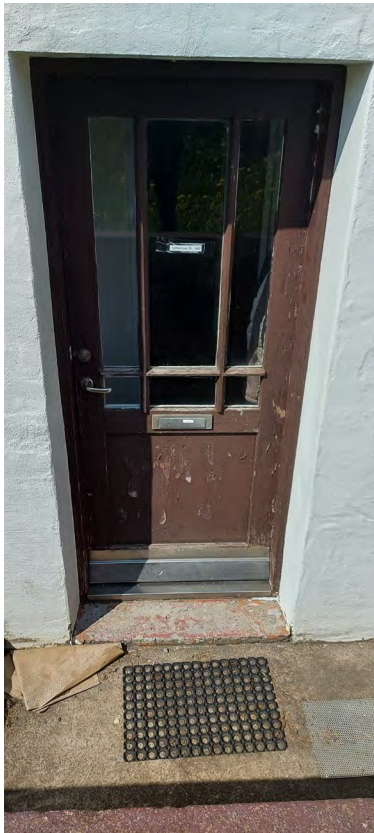
Mynd 12: Huga þarf að endurnýjun á kjallarahurðum í húsi 35.

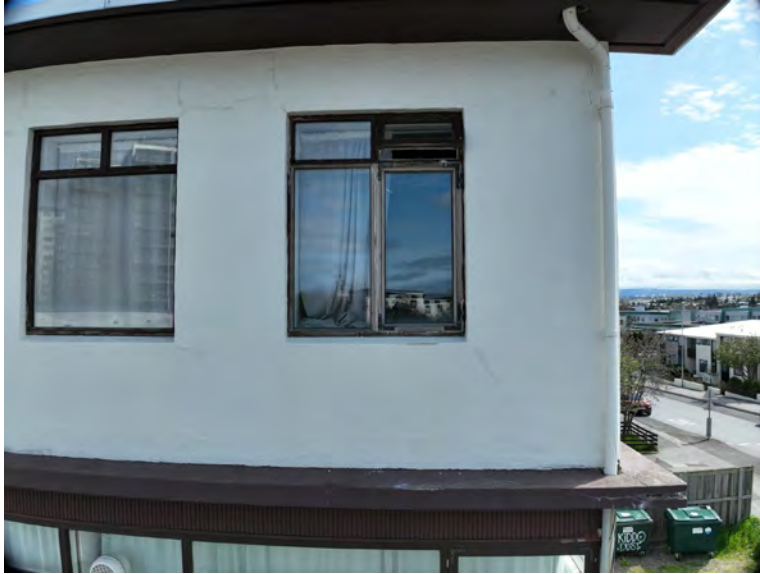
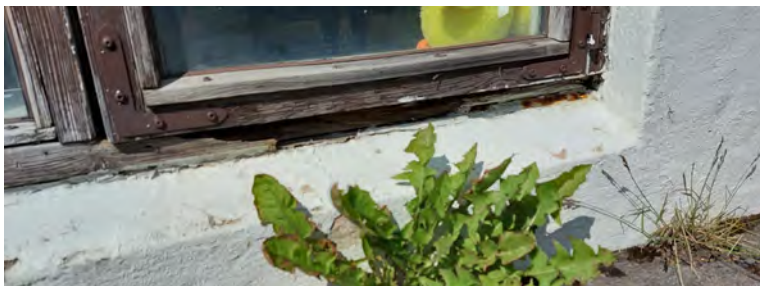
Mynd 13: Hér sést hvað gluggar í húsi 35 eru fúnir.

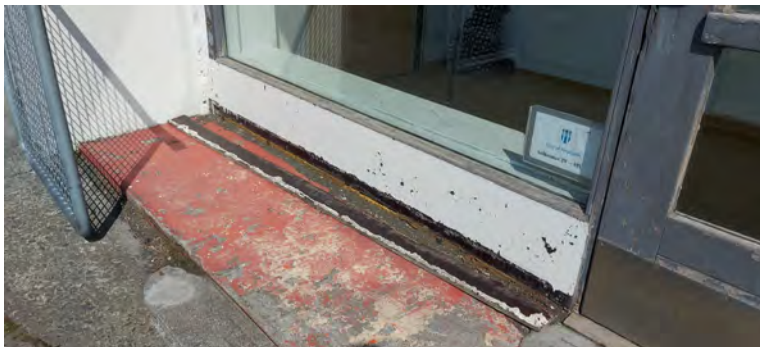
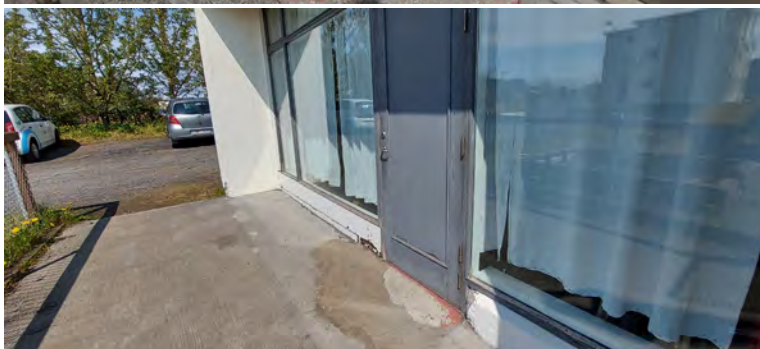
Mynd 14: Gluggar og hurðir að framanverðu í húsi 29 illa farnir.

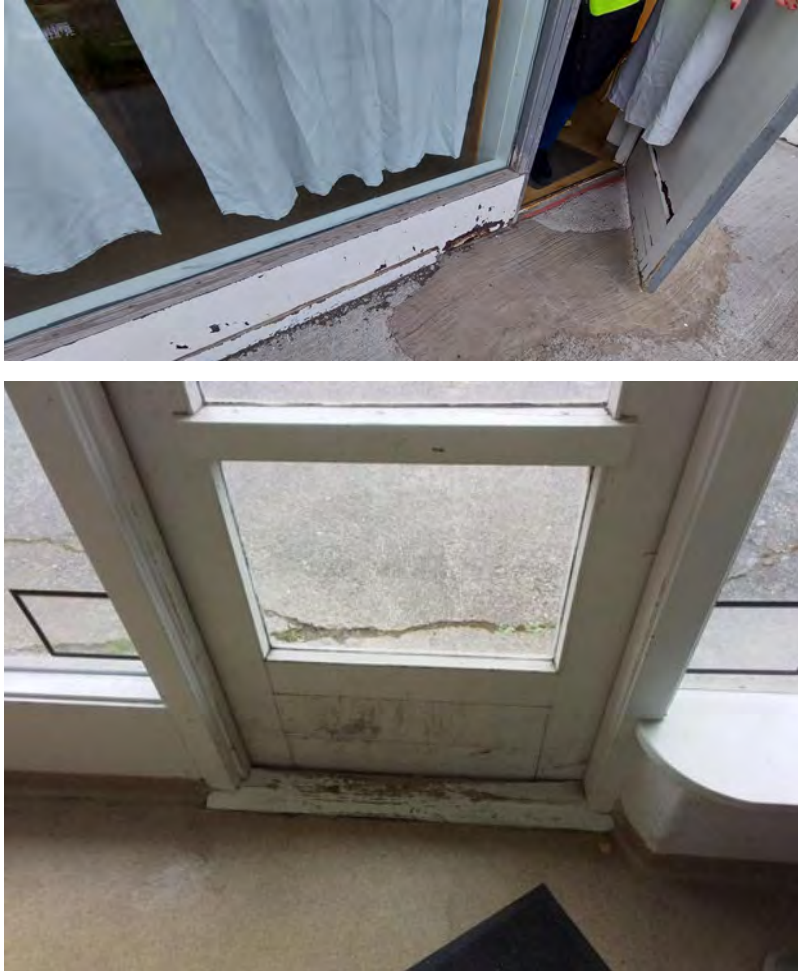
Mynd 15: Útihurðir eru illa farnar, bæði utan og innan.

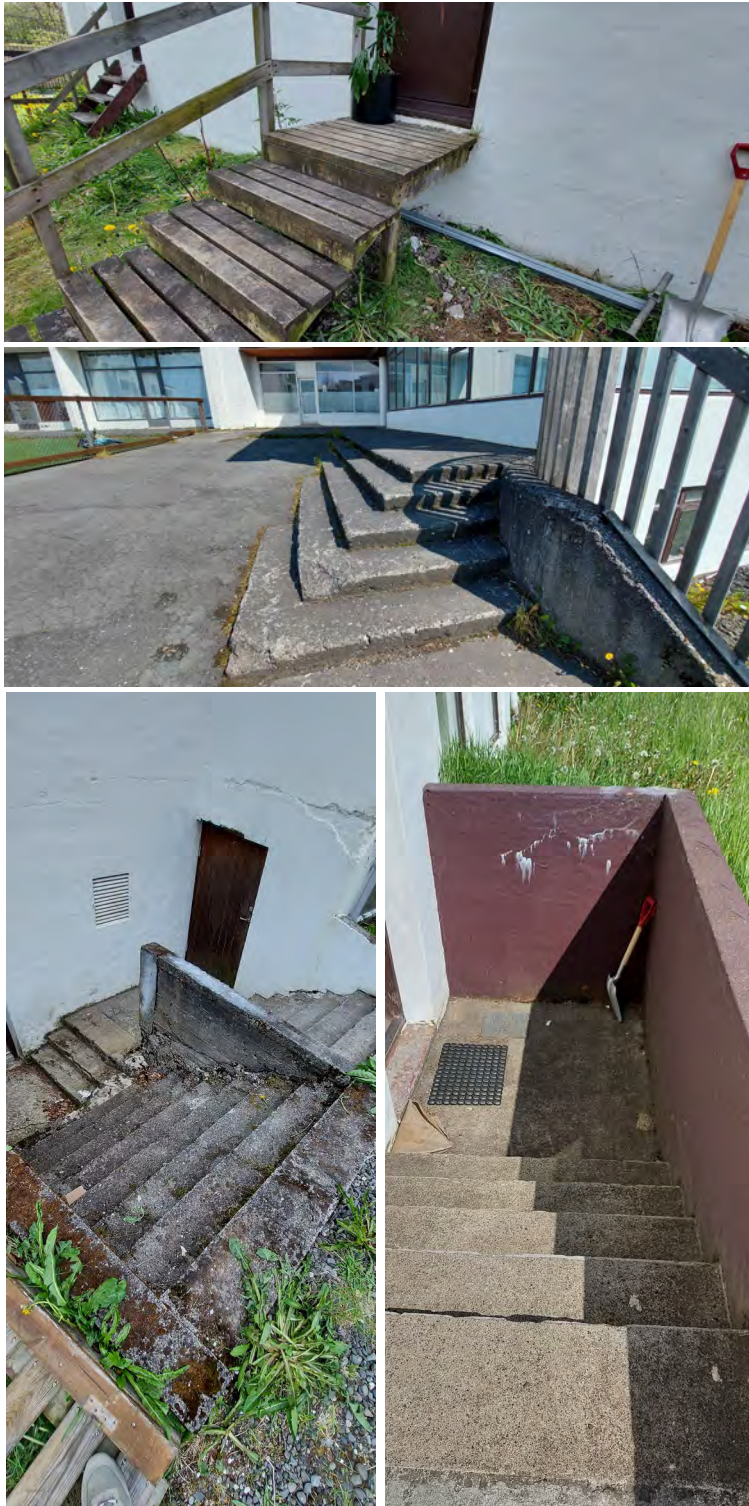
Mynd 16: Tröppur þarfnast viðgerða.

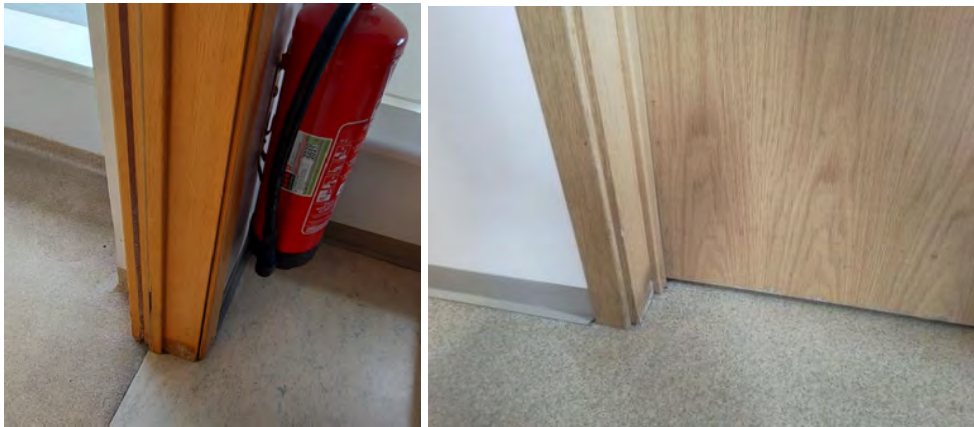
Mynd 17: Innihurðir og karmar illa farnir vegna raka.

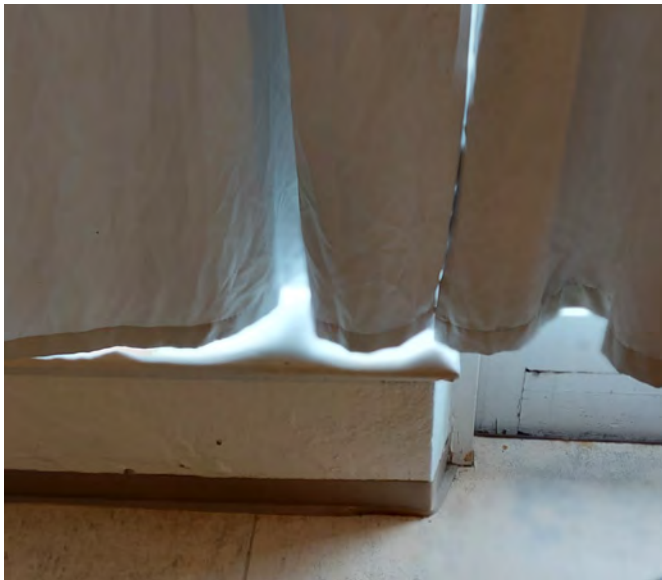
Mynd 18: Rakaskemmdir ná upp á vegg.

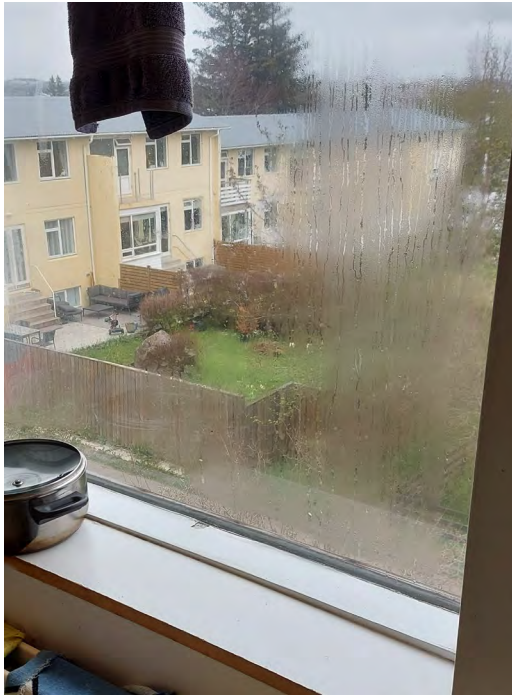
Mynd 19: Víða er móða í gleri, gluggar fúnir og almennt kominn tími á glugga í húsi 35 og framhlið á húsi 29.

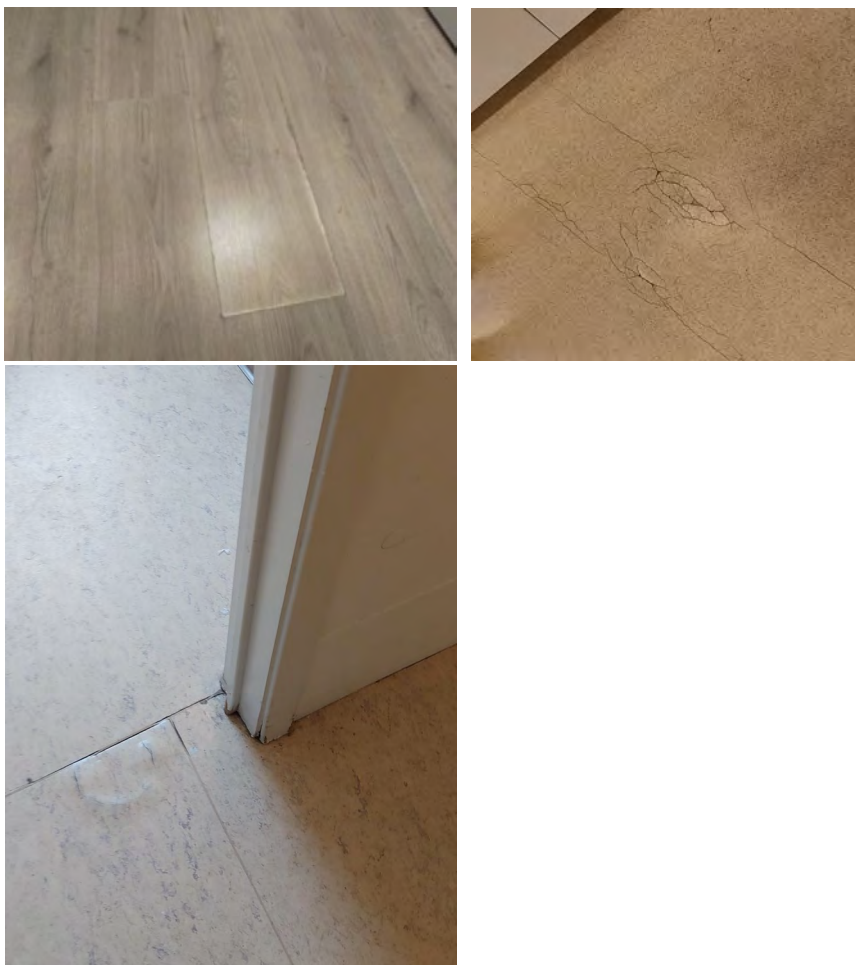
Mynd 20: Gólfefni er víða laust frá og ónýtt vegna rakaskemmda.

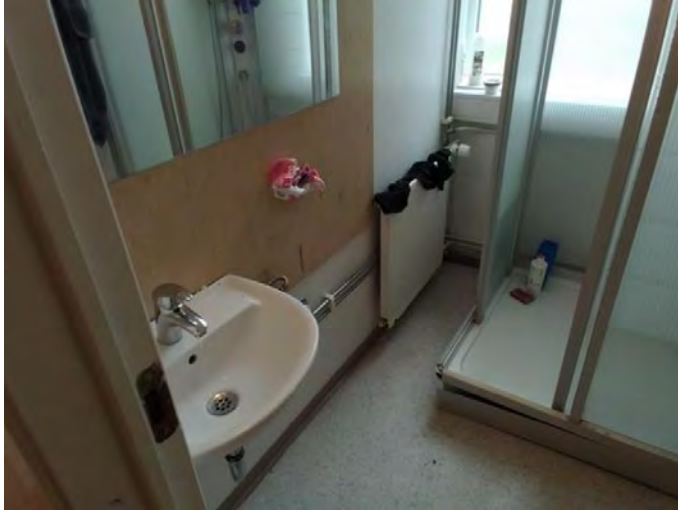
Mynd 21: Baðherbergin eru flest með sturtuklefa og salernisaðstöðu með handlaug, eins og sést eru þau komin til ára sinna.

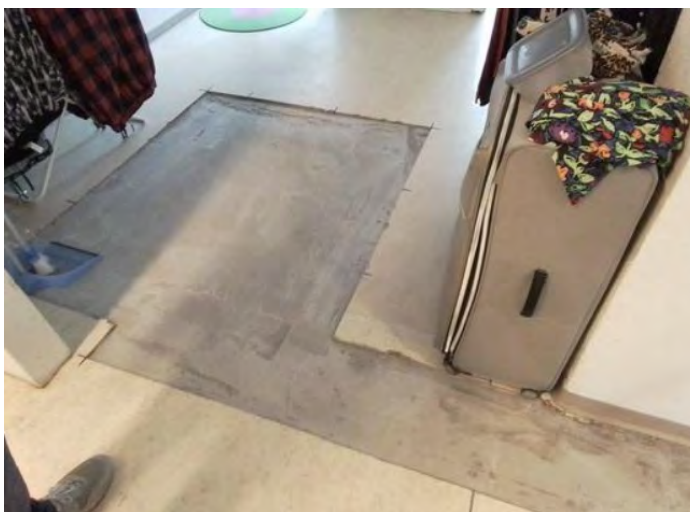
Mynd 23: Viðgerðir á gólfi í íbúð 0102 í húsi 29.

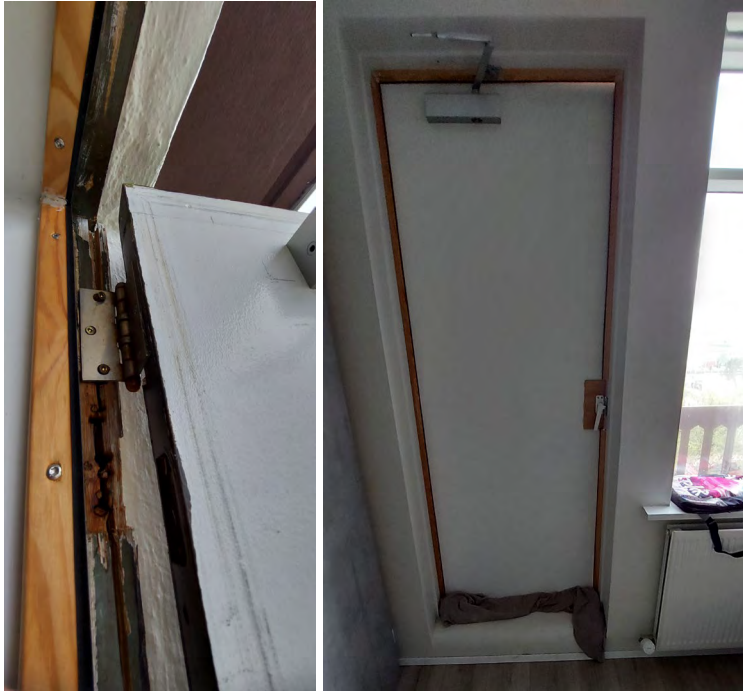
Mynd 24: Svalahurð ónýtt í íbúð 0201 á annari hæð í húsi 35.

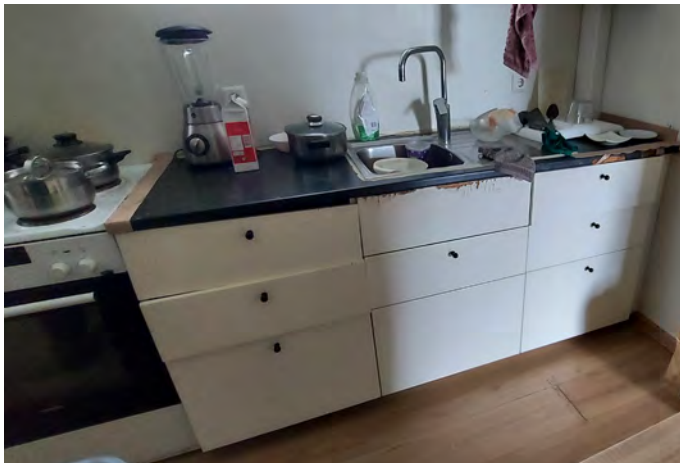
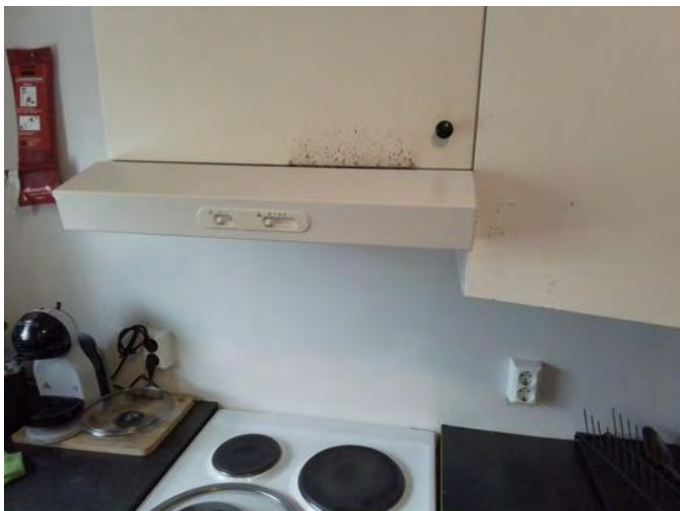
Mynd 25: Innréttingar í eldhúsi eru víða illa farnar og undantekningalaust efri skápar fyrir ofan víftur.

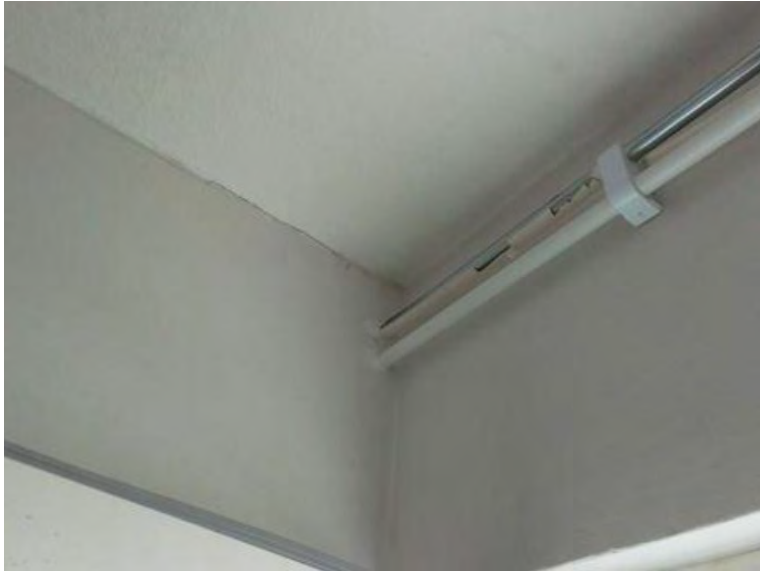
Mynd 26: Málning farin að flagna af lögnum.

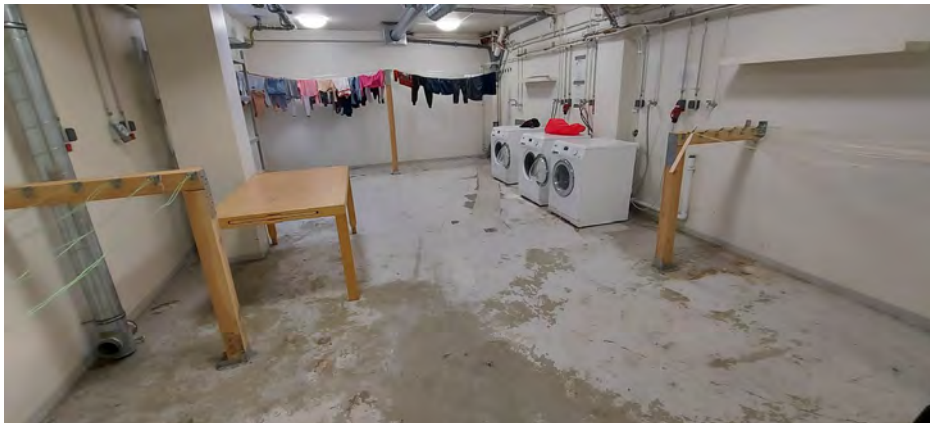
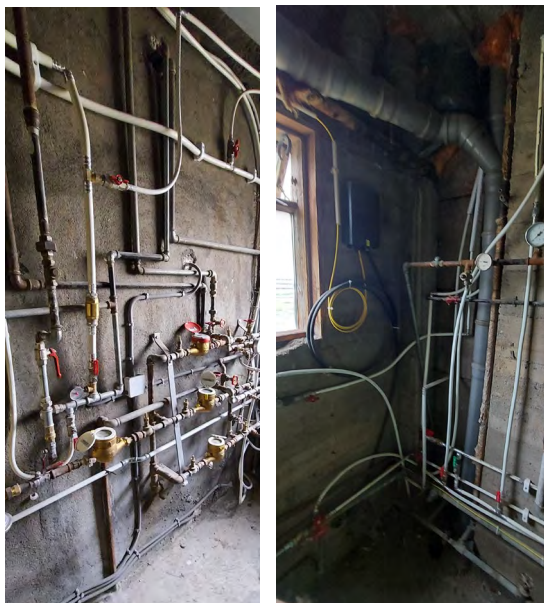
Mynd 27: Gólfíð í kjallara húss 35 mætti mála og eins í tæknirými.

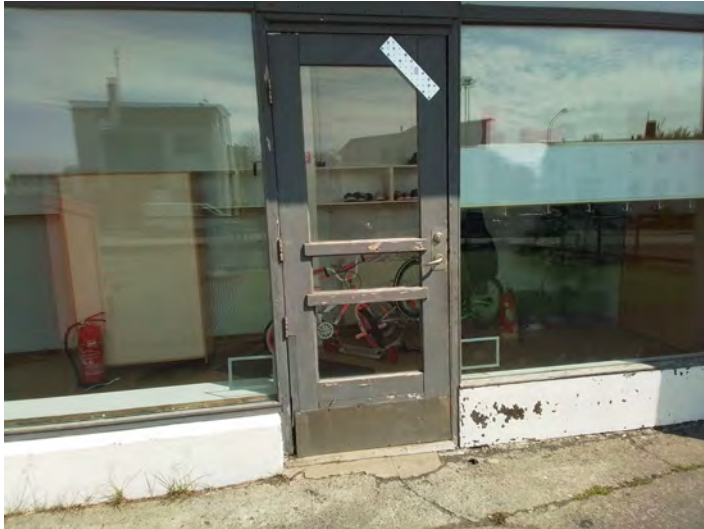
Photos 1: 07-06-23, 14:22:22

#138	Type: Defect	Project folder: Sólheimar 35
Deadline from: 06-06-23 - To: 06-06-23		Category / List: 09 EÁ - Frágangur uttanhúss / Gluggar og útihurðir
Description		Receiver
allar úti hurðir illa farnar		RECEIVED 07-06-23, 14:24:43 VSÓ Ráðgjöf Þórunn Arnardóttir
The latest comment		RESPONSIBLE 07-06-23, 14:22:12 VSÓ Ráðgjöf Þórunn Arnardóttir

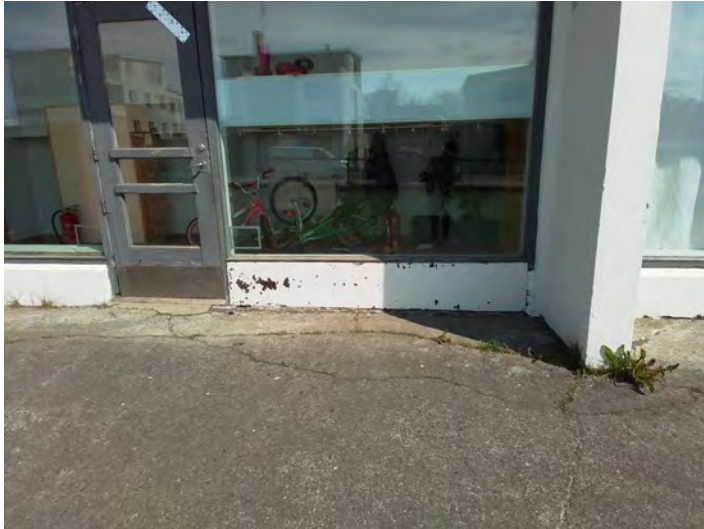
Photos 1: 07-06-23, 14:21:31

#137	Type: Defect	Project folder: Sólheimar 35	
Deadline from: 06-06-23 - To: 06-06-23		Category / List: 09 EÁ - Frágangur uttanhúss / Gluggar og útihurðir	
Description		Receiver	Responsible
ekki steypt undir glugga		RECEIVED VSÓ Ráðgjöf Þórunn Arnardóttir	CREATED VSÓ Ráðgjöf Þórunn Arnardóttir
The latest comment		0

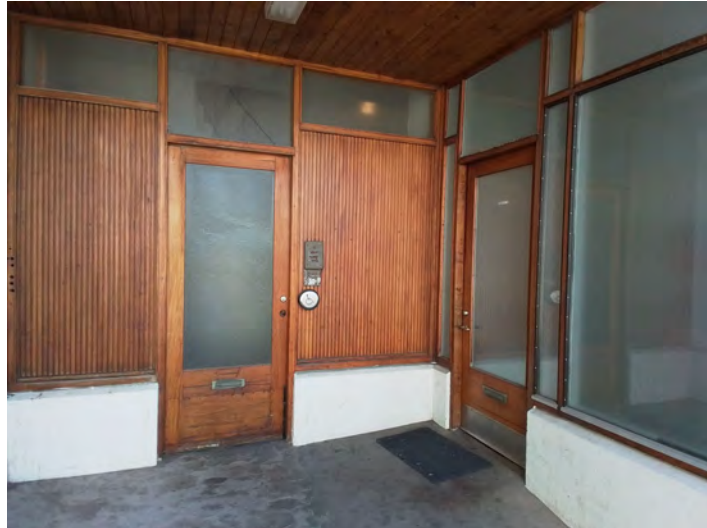
Photos 1: 07-06-23, 14:18:40

#134	Type: Defect	Project folder: Sólheimar 35	
Deadline from: 06-06-23 - To: 06-06-23		Category / List: 09 EÁ - Frágangur uttanhúss / Gluggar og útihurðir	
Description		Receiver	Responsible
Kominn tími á að pússa upp og vantar handfang.		RECEIVED VSÓ Ráðgjöf Þórunn Arnardóttir	CREATED VSÓ Ráðgjöf Þórunn Arnardóttir
The latest comment

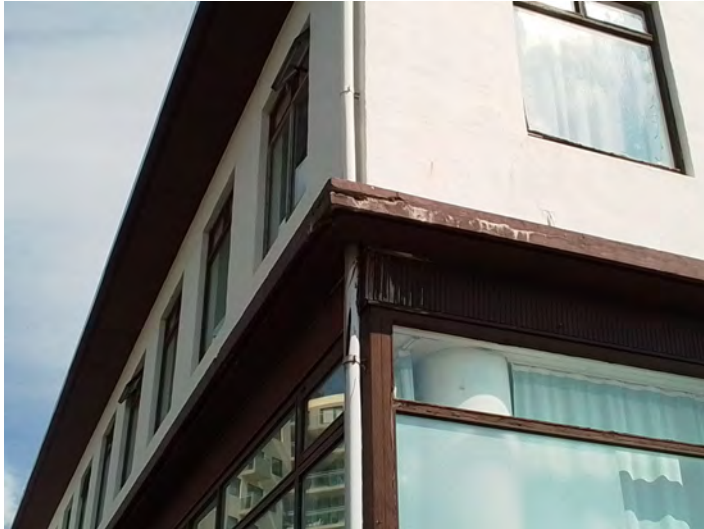
Photos 1: 07-06-23, 14:16:52

#132	Type: Defect	Project folder: Sólheimar 35	
Deadline from: 06-06-23 - To: 06-06-23		Category / List: 09 EÁ - Frágangur uttanhúss / Gluggar og útihurðir	
Description		Receiver	Responsible
Skyggni illa farið		RECEIVED VSÓ Ráðgjöf Þórunn Arnardóttir	CREATED VSÓ Ráðgjöf Þórunn Arnardóttir
The latest comment		0

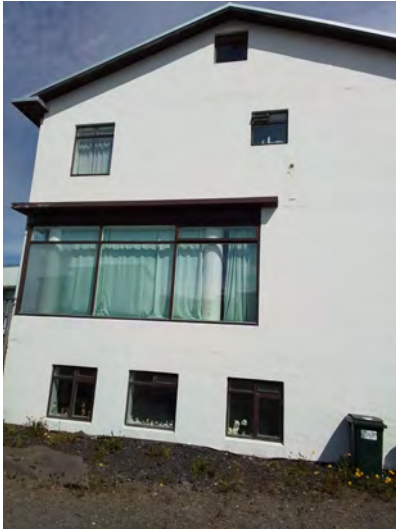
Photos 1: 07-06-23, 14:16:25

#131	Type: Defect	Project folder: Sólheimar 35	
Deadline from: 06-06-23 - To: 06-06-23		Category / List: 09 EÁ - Frágangur uttanhúss / Gluggar og útihurðir	
Description		Receiver	Responsible
gluggar illa farnir		RECEIVED 07-06-23, 14:24:43 VSÓ Ráðgjöf Þórunn Arnardóttir	CREATED 07-06-23, 14:16:08 VSÓ Ráðgjöf Þórunn Arnardóttir
The latest comment 0

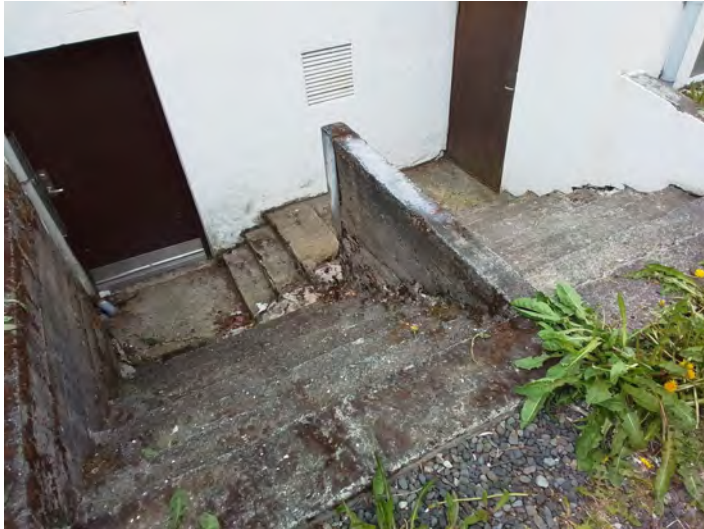
Photos 1: 07-06-23, 14:09:15

#122	Type: Defect	Project folder: Sólheimar 35	
Deadline from: 06-06-23 - To: 06-06-23		Category / List: 09 EÁ - Frágangur uttanhúss / Gluggar og útihurðir	
Description		Receiver	Responsible
illa farnar tröppur		RECEIVED VSÓ Ráðgjöf Þórunn Arnardóttir	CREATED VSÓ Ráðgjöf Þórunn Arnardóttir
The latest comment

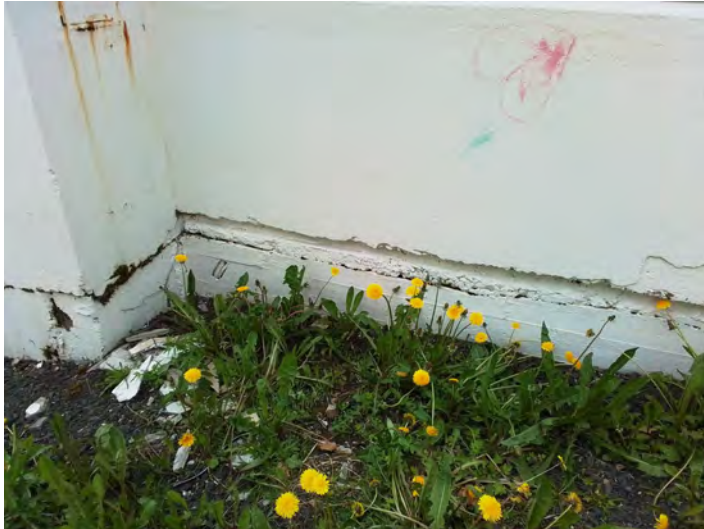
Photos 1: 07-06-23, 14:08:30

#121	Type: Defect	Project folder: Sólheimar 35	
Deadline from: 06-06-23 - To: 06-06-23		Category / List: 09 EÁ - Frágangur uttanhúss / Gluggar og útihurðir	
Description		Receiver	Responsible
illa farin steypan		RECEIVED VSÓ Ráðgjöf Þórunn Arnardóttir	CREATED VSÓ Ráðgjöf Þórunn Arnardóttir
The latest comment		0

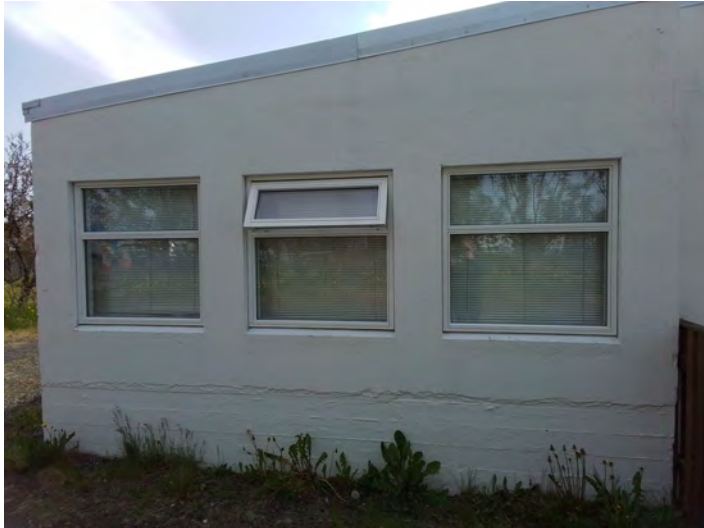
Photos 1: 07-06-23, 14:05:56

#117	Type: Defect	Project folder: Sólheimar 35	
Deadline from: 06-06-23 - To: 06-06-23		Category / List: 09 EÁ - Frágangur uttanhúss / Gluggar og útihurðir	
Description		Receiver	Responsible
áltrègluggar		RECEIVED VSÓ Ráðgjöf Þórunn Arnardóttir	CREATED VSÓ Ráðgjöf Þórunn Arnardóttir
07-06-23, 14:24:42		07-06-23, 14:05:47	
The latest comment

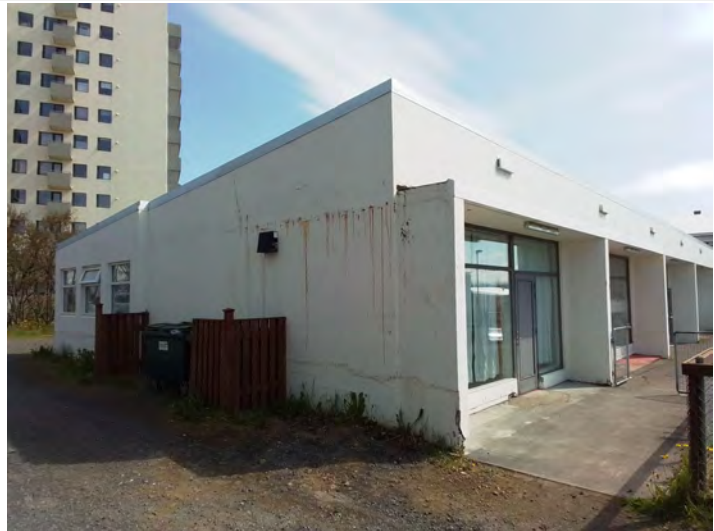
Photos 1: 07-06-23, 14:04:46

#116	Type: Defect	Project folder: Sólheimar 35
Deadline from: 06-06-23 - To: 06-06-23		Category / List: 09 EÁ - Frágangur uttanhúss
Description		Receiver
inndæling á sprungum vegna leka		RECEIVED 07-06-23, 14:24:42 VSÓ Ráðgjöf Þórunn Arnardóttir
The latest comment		Responsible
		CREATED 07-06-23, 14:04:35 VSÓ Ráðgjöf Þórunn Arnardóttir

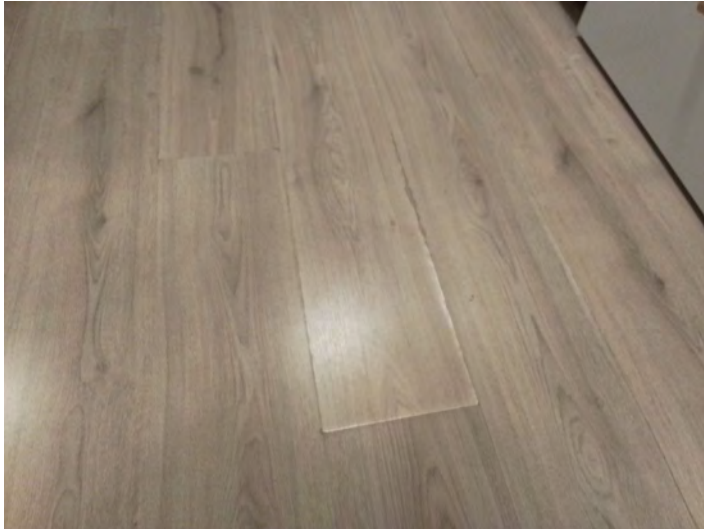
Photos 1: 05-06-23, 15:19:01

#115	Type: Defect	Project folder: Sólheimar 35
Deadline from: 04-06-23 - To: 04-06-23		Category / List: 09 EÁ - Frágangur innanhúss / Almennt
Description		Receiver
<p><i>The latest comment</i> Gólf bólgja</p>		<p>RECEIVED 05-06-23, 15:24:02</p> <p>VSÓ Ráðgjöf Þórunn Arnardóttir</p>
		Responsible
		<p>CREATED 05-06-23, 15:18:49</p> <p>VSÓ Ráðgjöf Þórunn Arnardóttir</p>

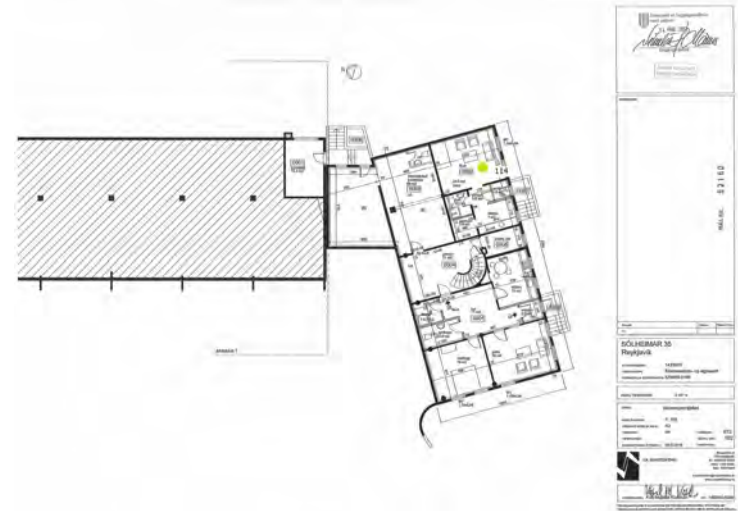
Drawing: 2016 102 Grunnmynd kjallari.pdf-

#114	Type: Defect	Project folder: Sólheimar 35
Deadline from: 04-06-23 - To: 04-06-23		Category / List: 09 EÁ - Frágangur innanhúss / Almennt
Description raki sturta lagnir gáfu sig, lagað 2020 ennþá að skila sér <i>The latest comment</i>		Receiver RECEIVED 05-06-23, 15:24:02 VSÓ Ráðgjöf Þórunn Arnardóttir
		Responsible CREATED 05-06-23, 15:16:43 VSÓ Ráðgjöf Þórunn Arnardóttir

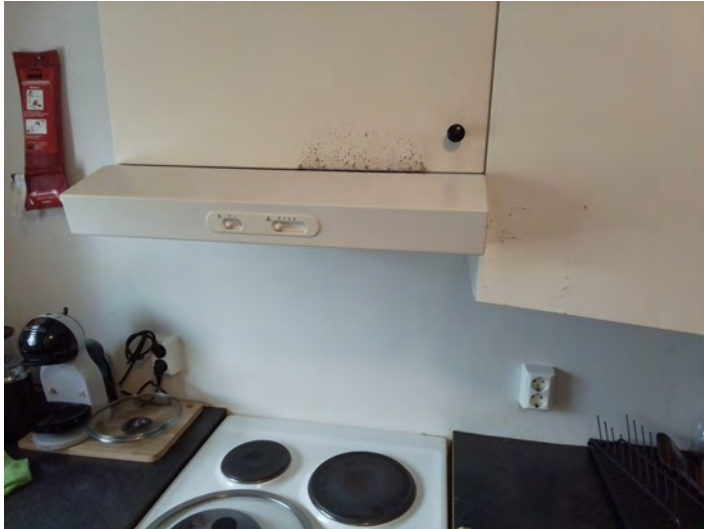
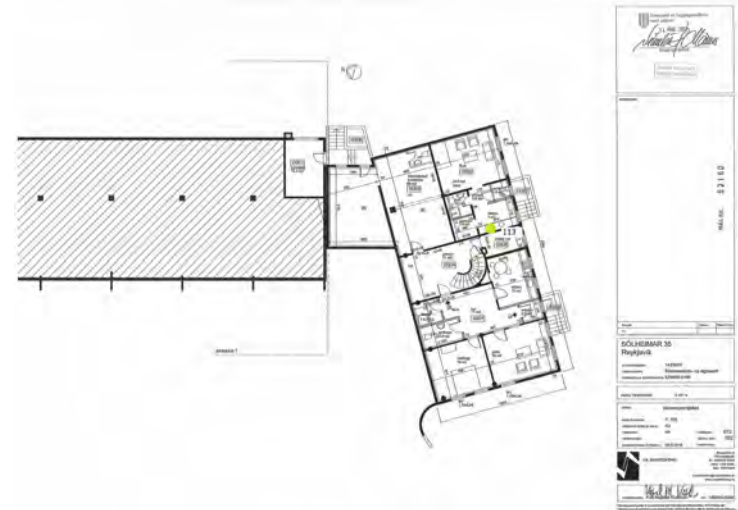
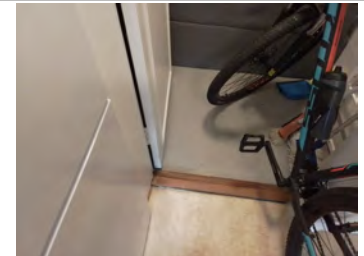
Photos 1: 05-06-23, 15:16:37

#113	Type: Defect	Project folder: Sólheimar 35
Deadline from: 04-06-23 - To: 04-06-23		Category / List: 09 EÁ - Frágangur innanhúss / Almennt
Description		Receiver
The latest comment		RECEIVED 05-06-23, 15:24:02 VSÓ Ráðgjöf Þórunn Arnardóttir
		RESPONSIBLE 05-06-23, 15:15:35 VSÓ Ráðgjöf Þórunn Arnardóttir

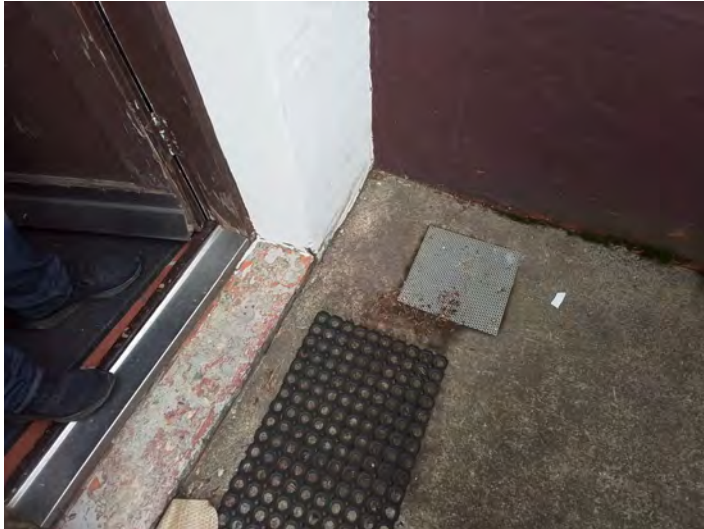
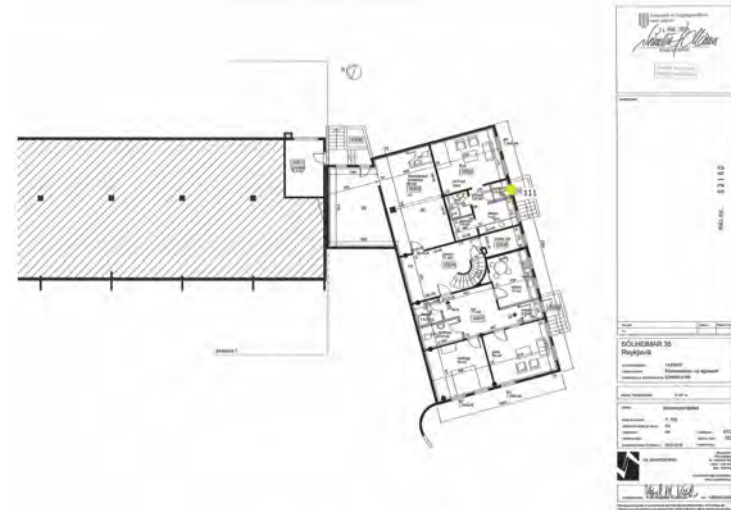
Photos 1: 05-06-23, 15:14:35

#111	Type: Defect	Project folder: Sólheimar 35
Deadline from: 04-06-23 - To: 04-06-23		Category / List: 09 EÁ - Frágangur innanhúss / Almennt
Description		Receiver
ónýtt		RECEIVED 05-06-23, 15:24:02 VSÓ Ráðgjöf Þórunn Arnardóttir
The latest comment		RESPONSIBLE 05-06-23, 15:14:02 VSÓ Ráðgjöf Þórunn Arnardóttir

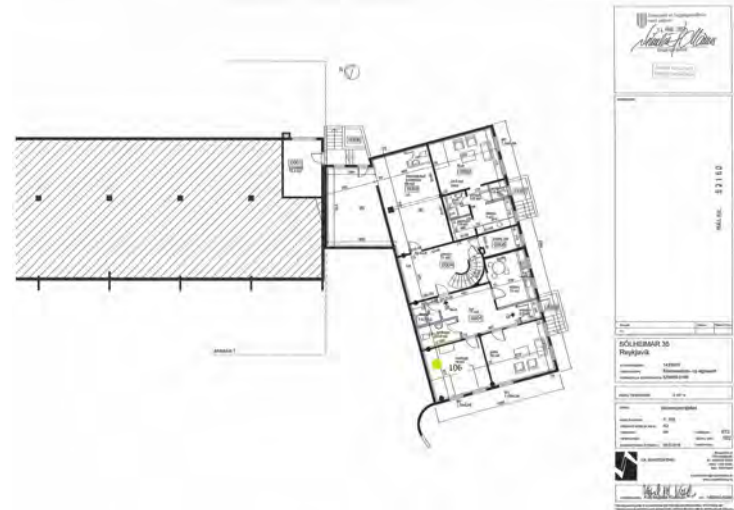
#106	Type: Defect	Project folder: Sólheimar 35	
Deadline from: 04-06-23 - To: 04-06-23		Category / List: 09 EÁ - Frágangur innanhúss / Almennt	
Description		Receiver	Responsible
reykskynjari		RECEIVED 05-06-23, 15:24:02 VSÓ Ráðgjöf Þórunn Arnardóttir	CREATED 05-06-23, 15:09:37 VSÓ Ráðgjöf Þórunn Arnardóttir
The latest comment 0

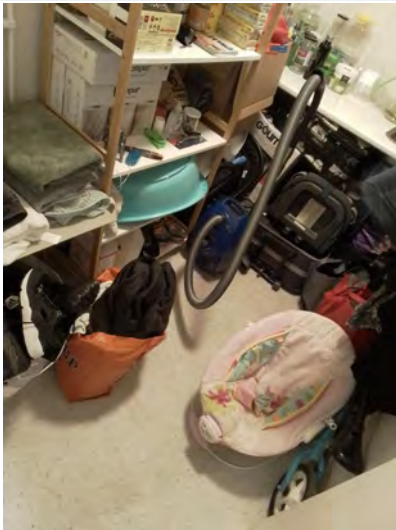
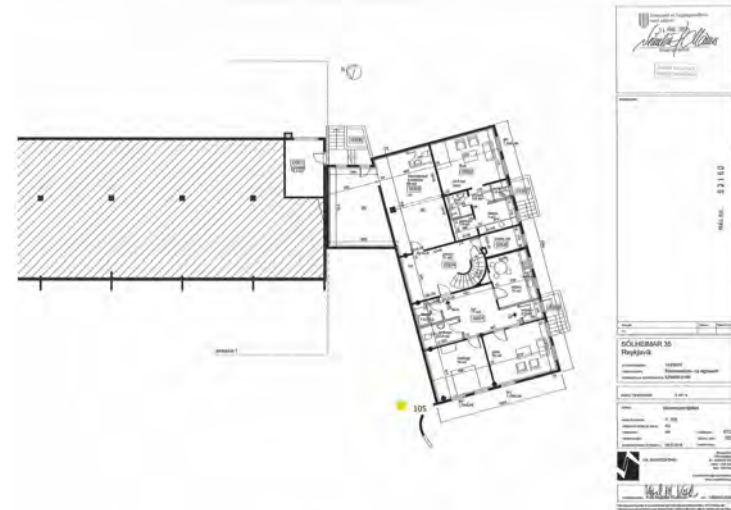
Photos 1: 05-06-23, 15:09:19

#105	Type: Defect	Project folder: Sólheimar 35	
Deadline from: 04-06-23 - To: 04-06-23		Category / List: 09 EÁ - Frágangur innanhúss / Almennt	
Description		Receiver	Responsible
geymsla		RECEIVED VSÓ Ráðgjöf Þórunn Arnardóttir	CREATED VSÓ Ráðgjöf Þórunn Arnardóttir
The latest comment		0

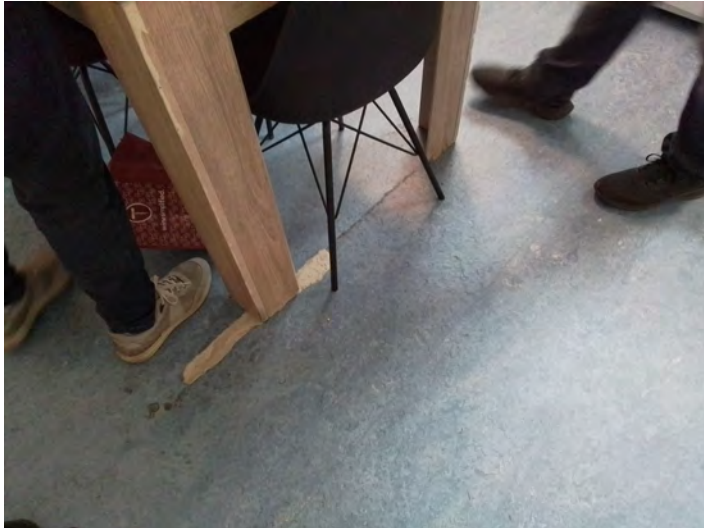
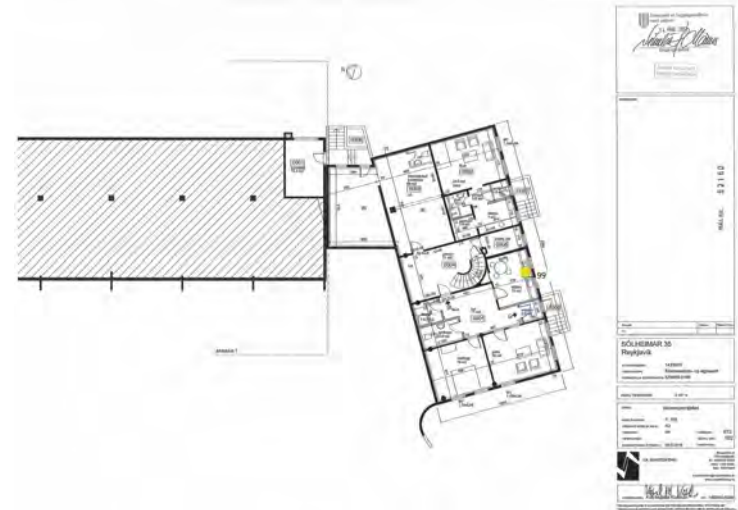
Photos 1: 05-06-23, 15:04:45

#99	Type: Defect	Project folder: Sólheimar 35	
Deadline from: 04-06-23 - To: 04-06-23		Category / List: 09 EÁ - Frágangur innanhúss / Almennt	
Description		Receiver	Responsible
ný innrétting dúkur 2018		RECEIVED 05-06-23, 15:24:01 VSÓ Ráðgjöf Þórunn Arnardóttir	CREATED 05-06-23, 15:04:13 VSÓ Ráðgjöf Þórunn Arnardóttir
<i>The latest comment</i>		0
