SÓLHEIMAR 29 OG 35

ÍBÚÐIR FYRIR HÆLISLEITENDUR

Ástandsmat og kostnaðaráætlun

Verknúmer: 23297

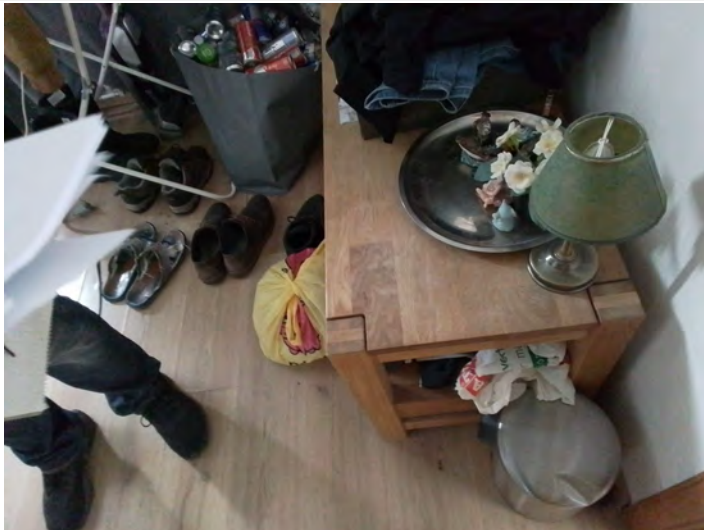
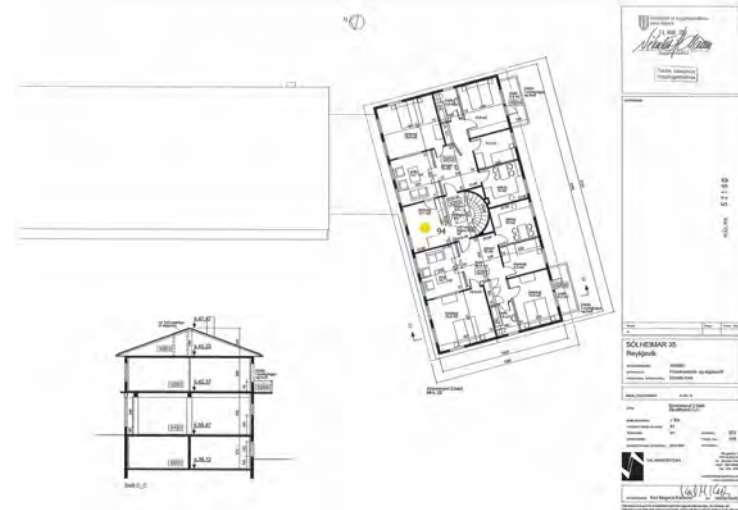
Photos 1: 05-06-23, 14:55:21

#94	Type: Defect	Project folder: Sólheimar 35
Deadline from: 04-06-23 - To: 04-06-23		Category / List: 09 EÁ - Frágangur innanhúss / Almennt
Description		Receiver
ónýtt gólf		RECEIVED 05-06-23, 15:24:01 VSÓ Ráðgjöf Þórunn Arnardóttir
The latest comment		RESPONSIBLE 05-06-23, 14:54:51 VSÓ Ráðgjöf Þórunn Arnardóttir

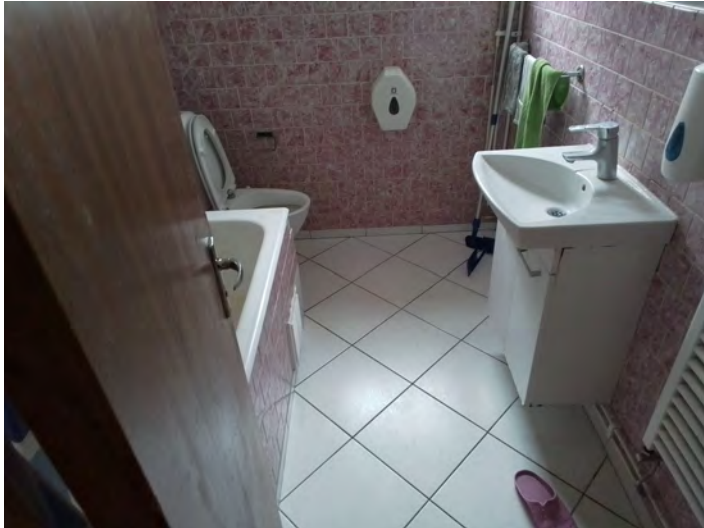
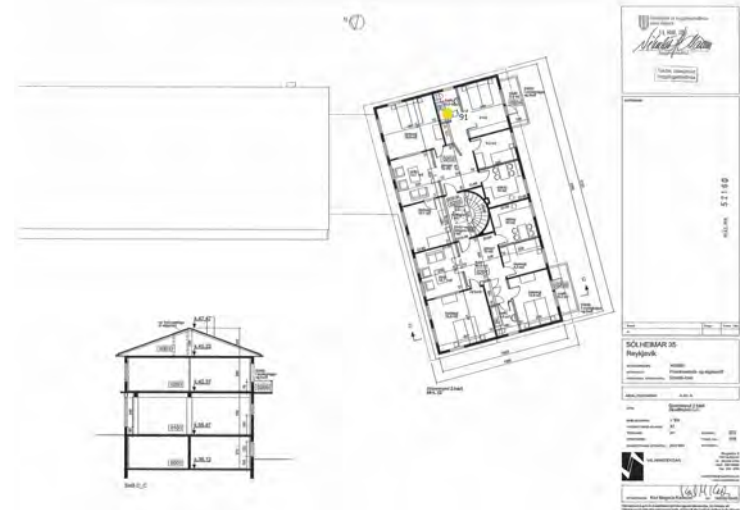
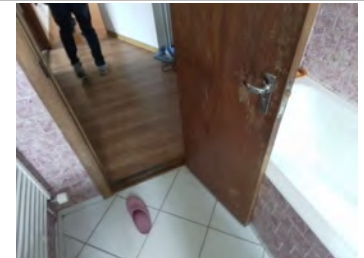
Photos 1: 05-06-23, 14:52:37

#91	Type: Defect	Project folder: Sólheimar 35
Deadline from: 04-06-23 - To: 04-06-23		Category / List: 09 EÁ - Frágangur innanhúss / Almennt
Description		Receiver
ónýtt		RECEIVED 05-06-23, 15:24:01 VSÓ Ráðgjöf Þórunn Arnardóttir
The latest comment		Responsible
		CREATED 05-06-23, 14:51:40 VSÓ Ráðgjöf Þórunn Arnardóttir

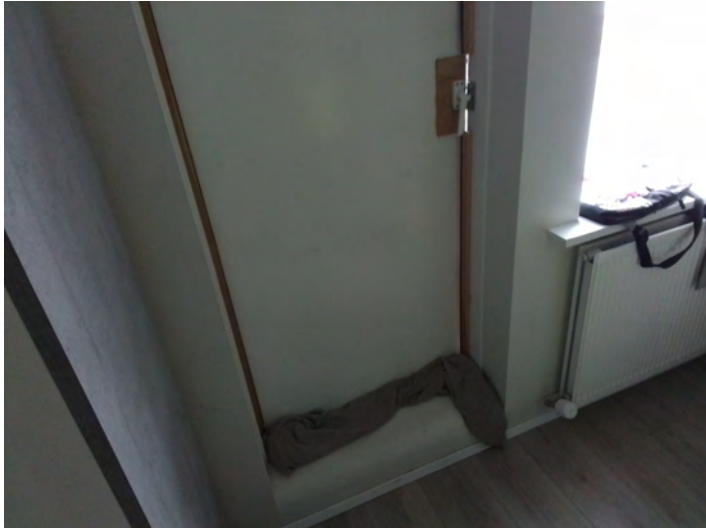
#87	Type: Defect	Project folder: Sólheimar 35	
Deadline from: 04-06-23 - To: 04-06-23		Category / List: 09 EÁ - Frágangur innanhúss / Almennt	
Description		Receiver	Responsible
ónýt hurð og moða í gleri		RECEIVED 05-06-23, 15:24:01 VSÓ Ráðgjöf Þórunn Arnardóttir	CREATED 05-06-23, 14:45:52 VSÓ Ráðgjöf Þórunn Arnardóttir
The latest comment			
0

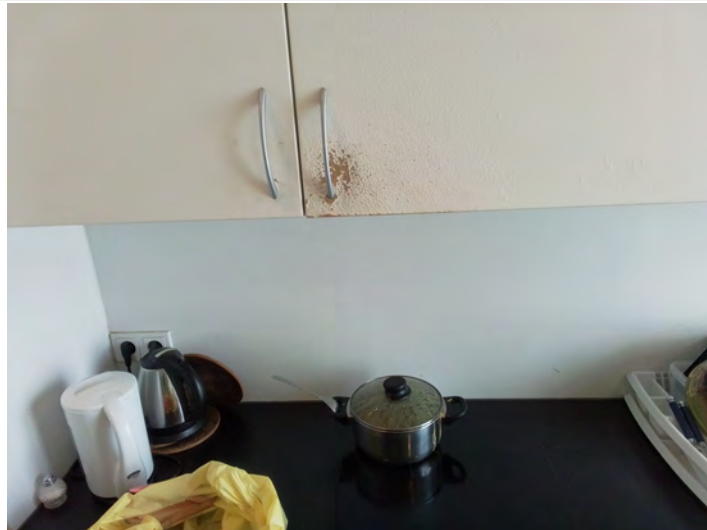
#81	Type: Defect	Project folder: Sólheimar 35	
Deadline from: 04-06-23 - To: 04-06-23		Category / List: 09 EÁ - Frágangur innanhúss / Almennt	
Description		Receiver	Responsible
moða í gleri og smá skemmdir í gólfi innrétting skemmd hiti The latest comment		RECEIVED 05-06-23, 15:24:01 VSÓ Ráðgjöf Þórunn Arnardóttir	CREATED 05-06-23, 14:42:03 VSÓ Ráðgjöf Þórunn Arnardóttir

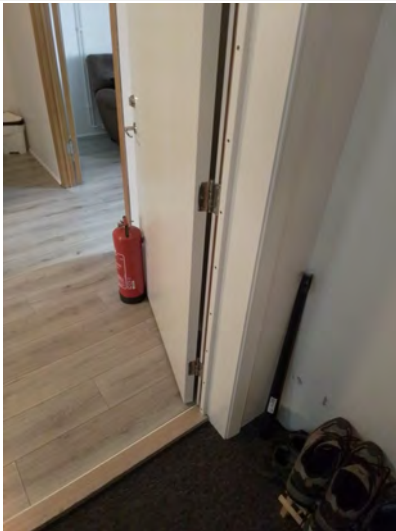
#80	Type: Defect	Project folder: Sólheimar 35	
Deadline from: 04-06-23 - To: 04-06-23		Category / List: 09 EÁ - Frágangur innanhúss / Almennt	
Description		Receiver	Responsible
veggjatitla 2019..20 og allt skipt út		RECEIVED VSÓ Ráðgjöf Þórunn Arnardóttir	CREATED VSÓ Ráðgjöf Þórunn Arnardóttir
The latest comment		0

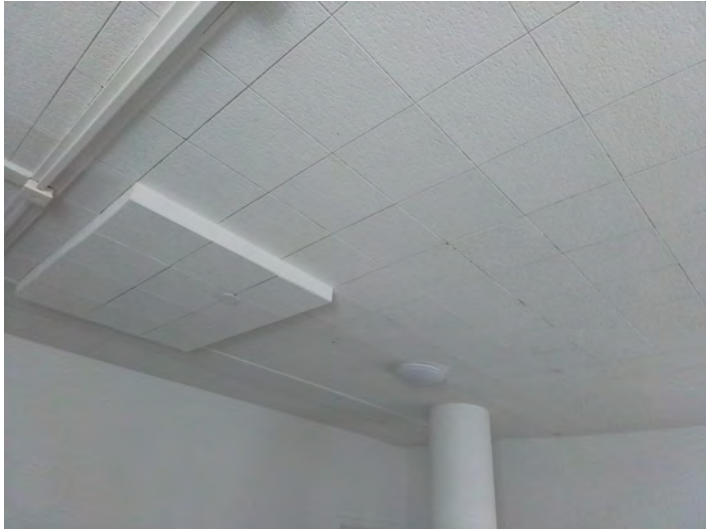
#71	Type: Defect	Project folder: Sólheimar 35
Deadline from: 04-06-23 - To: 04-06-23		Category / List: 09 EÁ - Frágangur innanhúss / Almennt
Description		Receiver
hljóðisogsplötur í lofti		RECEIVED 05-06-23, 15:24:00 VSÓ Ráðgjöf Þórunn Arnardóttir
The latest comment		RESPONSIBLE 05-06-23, 14:34:37 VSÓ Ráðgjöf Þórunn Arnardóttir

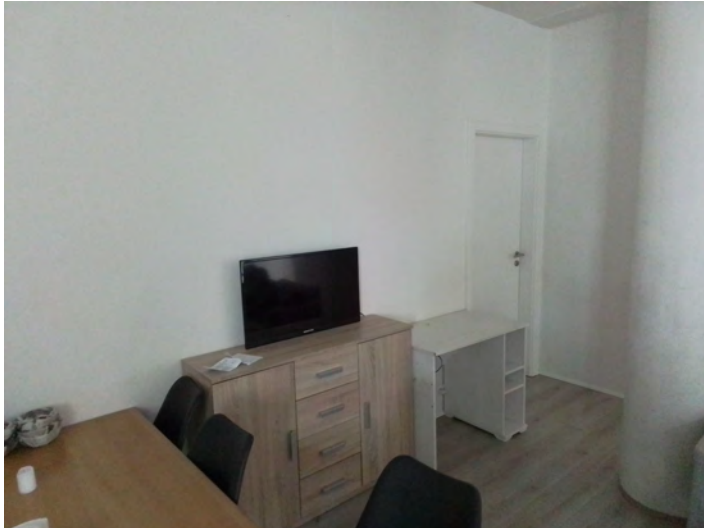
#70	Type: Defect	Project folder: Sólheimar 35	
Deadline from: 04-06-23 - To: 04-06-23		Category / List: 09 EÁ - Frágangur innanhúss / Almennt	
Description		Receiver	Responsible
bætt við herbergj		RECEIVED VSÓ Ráðgjöf Þórunn Arnardóttir	CREATED VSÓ Ráðgjöf Þórunn Arnardóttir
05-06-23, 15:24:00		05-06-23, 14:34:04	
The latest comment		0

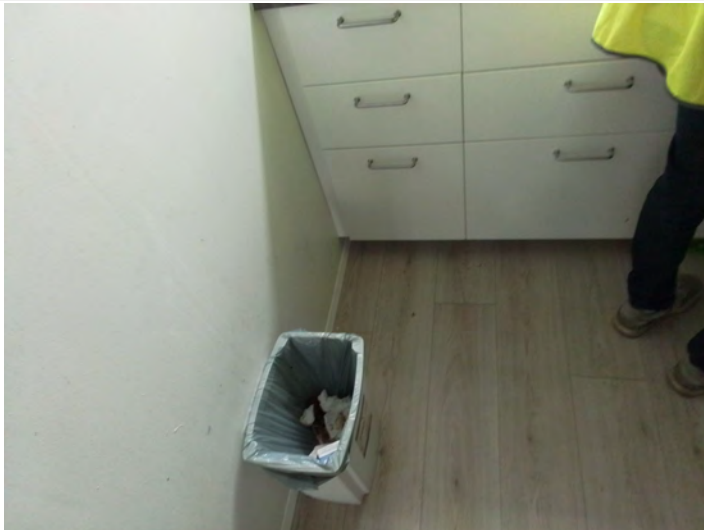
#69	Type: Defect	Project folder: Sólheimar 35	
Deadline from: 04-06-23 - To: 04-06-23		Category / List: 09 EÁ - Frágangur innanhúss / Almennt	
Description		Receiver	Responsible
skipt um gólf og eldhús 2021		RECEIVED VSÓ Ráðgjöf Þórunn Arnardóttir	CREATED VSÓ Ráðgjöf Þórunn Arnardóttir
05-06-23, 15:24:00		05-06-23, 14:32:38	
The latest comment

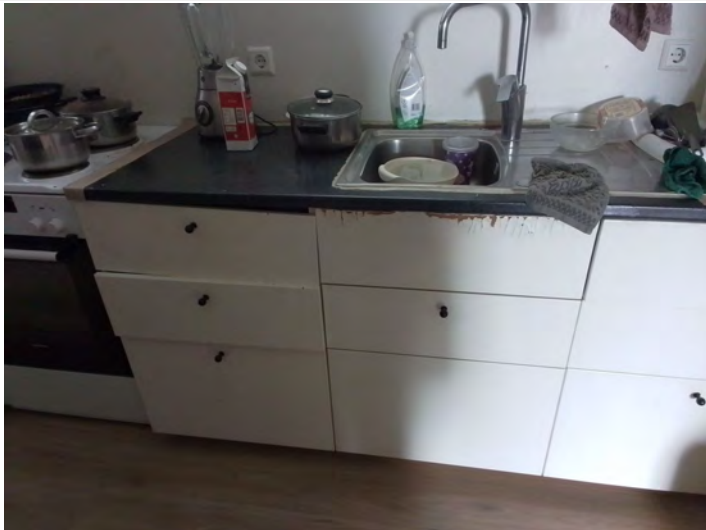
#62	Type: Defect	Project folder: Sólheimar 35
Deadline from: 04-06-23 - To: 04-06-23		Category / List: 09 EÁ - Frágangur innanhúss / Almennt
Description		Receiver
ónýtt eld		RECEIVED 05-06-23, 15:24:00 VSÓ Ráðgjöf Þórunn Arnardóttir
The latest comment		Responsible CREATED 05-06-23, 14:25:48 VSÓ Ráðgjöf Þórunn Arnardóttir

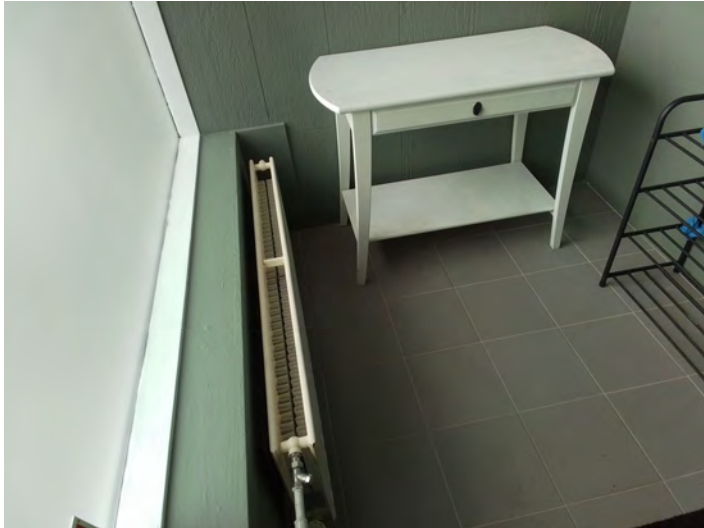
#54	Type: Defect	Project folder: Sólheimar 35	
Deadline from: 04-06-23 - To: 04-06-23		Category / List: 09 EÁ - Frágangur innanhúss / Almennt	
Description		Receiver	Responsible
Vantar reykskynjara		RECEIVED VSÓ Ráðgjöf Þórunn Arnardóttir	CREATED VSÓ Ráðgjöf Þórunn Arnardóttir
The latest comment

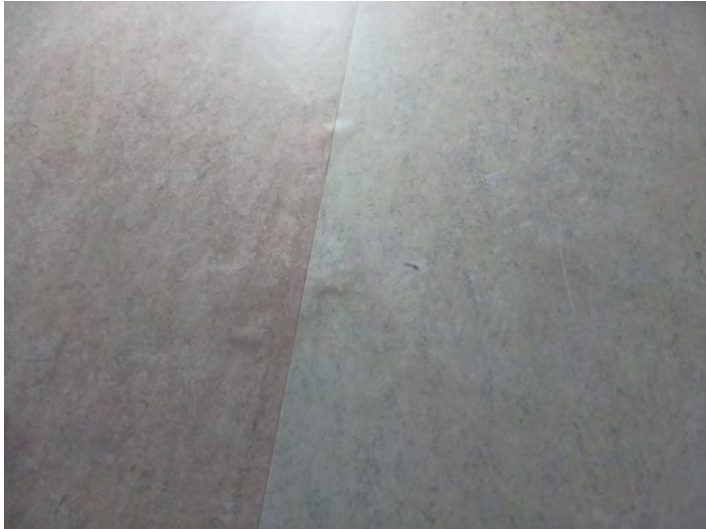
Photos 1: 05-06-23, 14:04:31

#35	Type: Defect	Project folder: Sólheimar 35	
Deadline from: 04-06-23 - To: 04-06-23		Category / List: 09 EÁ - Frágangur innanhúss / Almennt	
Description		Receiver	Responsible
Bólgur í dúk		RECEIVED VSÓ Ráðgjöf Þórunn Arnardóttir	CREATED VSÓ Ráðgjöf Þórunn Arnardóttir
The latest comment

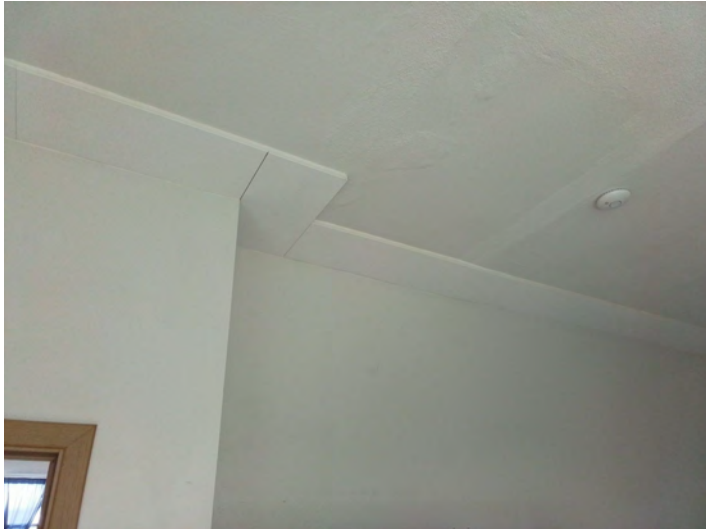
Photos 1: 05-06-23, 13:59:34

#31	Type: Defect	Project folder: Sólheimar 35	
Deadline from: 04-06-23 - To: 04-06-23		Category / List: 09 EÁ - Frágangur innanhúss / Almennt	
Description		Receiver	Responsible
hljóðdeyfiplötur í lofti		RECEIVED 05-06-23, 15:23:59 VSÓ Ráðgjöf Þórunn Arnardóttir	CREATED 05-06-23, 13:59:24 VSÓ Ráðgjöf Þórunn Arnardóttir
The latest comment 0

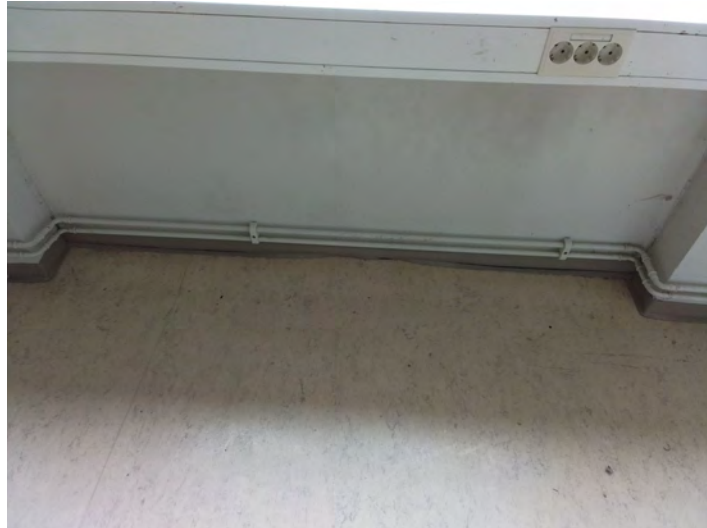
Photos 1: 05-06-23, 13:59:00

#30	Type: Defect	Project folder: Sólheimar 35	
Deadline from: 04-06-23 - To: 04-06-23		Category / List: 09 EÁ - Frágangur innanhúss / Almennt	
Description		Receiver	Responsible
Laus dúkur bólginn		RECEIVED 05-06-23, 15:23:59 VSÓ Ráðgjöf Þórunn Arnardóttir	CREATED 05-06-23, 13:58:51 VSÓ Ráðgjöf Þórunn Arnardóttir
The latest comment 0

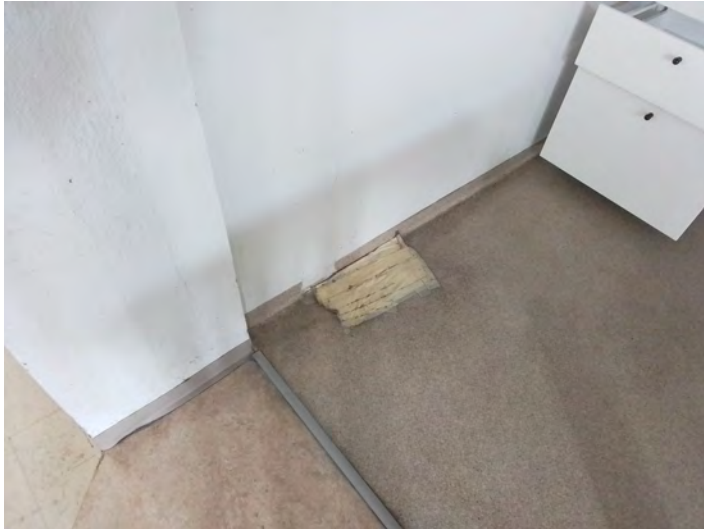
Photos 1: 05-06-23, 13:57:17

#27	Type: Defect	Project folder: Sólheimar 35
Deadline from: 04-06-23 - To: 04-06-23		Category / List: 09 EÁ - Frágangur innanhúss / Almennt
Description		Receiver
niðurfall sem á að steypa í		RECEIVED 05-06-23, 15:23:59
		VSÓ Ráðgjöf Þórunn Arnardóttir
The latest comment		RESPONSIBLE
		CREATED 05-06-23, 13:56:59
		VSÓ Ráðgjöf Þórunn Arnardóttir

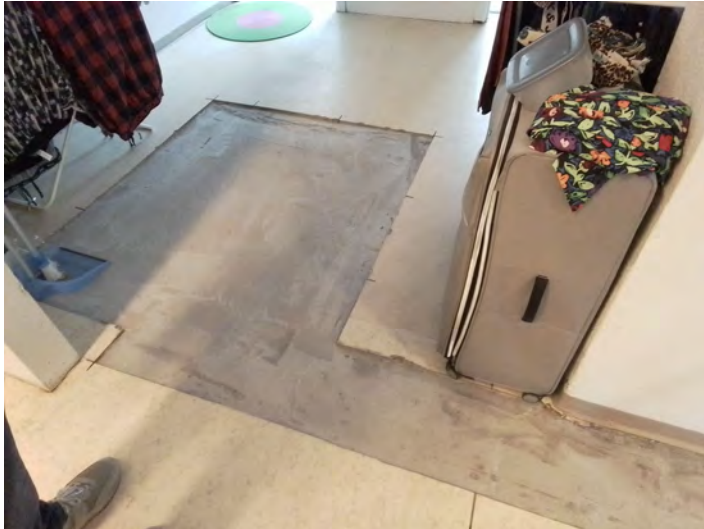
Photos 1: 05-06-23, 13:49:49

#18	Type: Defect	Project folder: Sólheimar 35
Deadline from: 04-06-23 - To: 04-06-23		Category / List: 09 EÁ - Frágangur innanhúss / Almennt
Description		Receiver
Skipt um skólprör		RECEIVED 05-06-23, 15:23:58
		VSÓ Ráðgjöf Þórunn Arnardóttir
The latest comment		Responsible
		CREATED 05-06-23, 13:49:26
		VSÓ Ráðgjöf Þórunn Arnardóttir

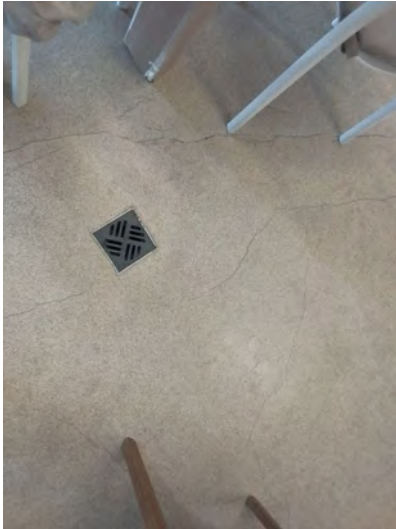
Photos 1: 05-06-23, 13:41:30

#8	Type: Defect	Project folder: Sólheimar 35	
Deadline from: 04-06-23 - To: 04-06-23		Category / List: 09 EÁ - Frágangur innanhúss / Almennt	
Description		Receiver	Responsible
Sprungur í gólfi		RECEIVED 05-06-23, 15:23:58 VSÓ Ráðgjöf Þórunn Arnardóttir	CREATED 05-06-23, 13:41:16 VSÓ Ráðgjöf Þórunn Arnardóttir
The latest comment

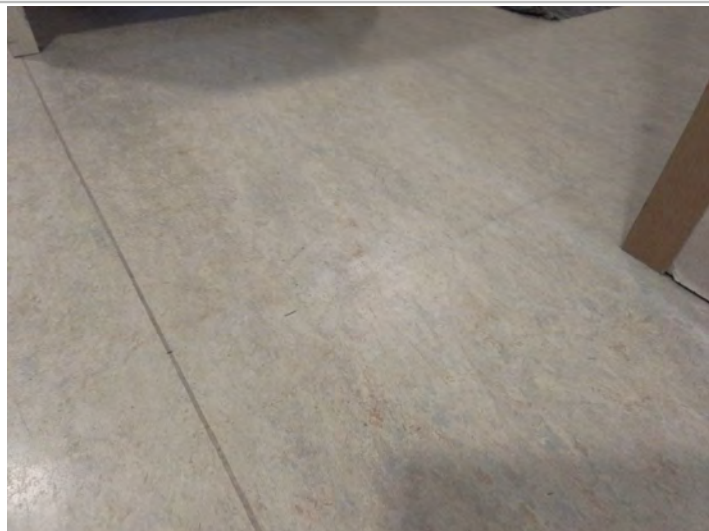
#3	Type: Defect	Project folder: Sólheimar 35
Deadline from: 04-06-23 - To: 04-06-23		Category / List: 09 EÁ - Frágangur innanhúss / Almennt
Description		Receiver
Los í dúk		RECEIVED 05-06-23, 15:23:58
		VSÓ Ráðgjöf Þórunn Arnardóttir
		RESPONSIBLE 05-06-23, 13:36:43
		VSÓ Ráðgjöf Þórunn Arnardóttir
The latest comment		
0
